APPENDIX B: Existing Conditions

Route 9W Corridor Management Plan

**Towns of Marlborough and Lloyd
Ulster County, NY**

EXISTING CONDITIONS REPORT

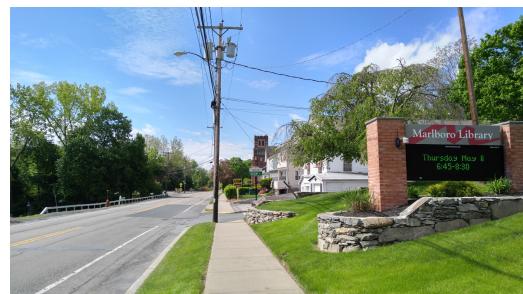
At the intersection of Route 9W and Bloom Street is the Marlboro Free Library to the northwest (Fig. 1) and a cemetery and funeral home to the northeast (Fig. 2 & 3). Along the west side of the road there is a five (5') foot sidewalk and six (6') foot shoulder in good condition. The east side of the road has a six (6') foot shoulder between, most of which is in poor condition with some potholes and broken pavement (Fig. 2). The front yard of the funeral home on the east side is entirely paved with an open curb cut across its frontage (Fig. 3). Although there are differences in the asphalt, the funeral home uses traffic cones to demarcate the parking lot from the road. This is similar throughout much of Section One on the east side, where the pavement extends continuously from the roadway edge to the front of the commercial buildings with no protected sidewalk or pedestrian realm. In some cases, this ambiguous area is used for on-street parking and loading activities. Drainage issues are also evident on both sides of the roadway as the west side is full of debris and the east side has been eroded, exposing drainage grates.

Figure 1: Sidewalk and shoulder conditions on Route 9W southbound (west) at Marlboro Library, looking south

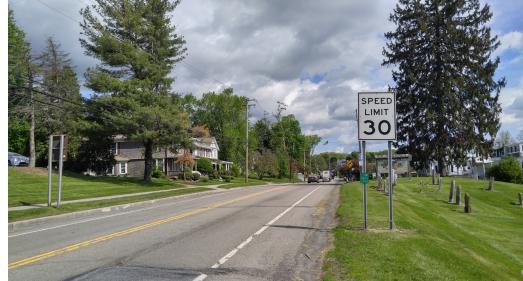
Figure 2: Shoulder pavement conditions on Route 9 northbound (east) at cemetery, looking north

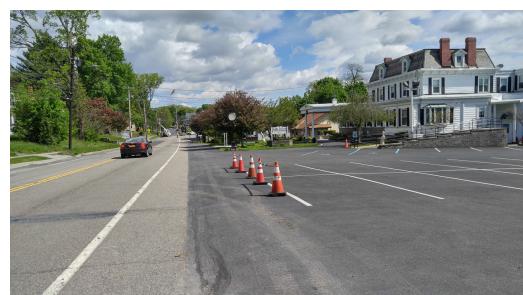
Figure 3: Shoulder and parking lot at funeral home on Route 9W north, looking north

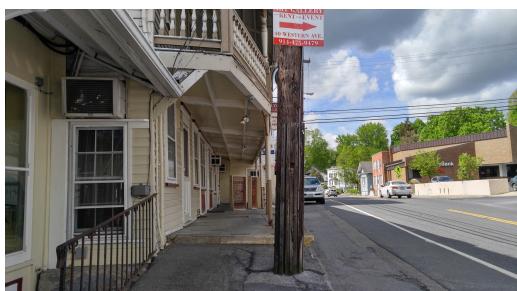
Figure 8: Steps and cracks in sidewalk adjacent to Raccoon Saloon on 9W northbound, looking south

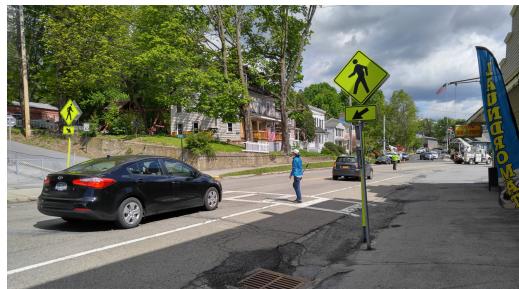
A non-signalized crosswalk, with cautionary pedestrian crossing signs, crosses Route 9W to the south of Dubois Street to the commercial businesses on the east side (Fig. 4). Between Dubois Street and King Street along the west side, the sidewalk is slightly deteriorated and, although the sidewalk continues across the residential driveway aprons to King Street, it slopes steeply towards the road at the driveways. There is only a stop bar for the heavy one-way traffic from King Street onto Route 9W, but no crosswalk (Fig. 5). The sidewalk on the northwest corner of the King Street/9W intersection does not connect, but rather transitions into a ten (10') foot paved shoulder (Fig. 5). North of the intersection, between King Street and Western Avenue on the west side, the sidewalk widens to seven (7') feet in width with a large section of broken curb and the shoulder runs between three (3') and five (5') feet in width. A unique element of the block is a four (4') foot interior sidewalk between buildings that provides pedestrian access through to King Street. Slightly further north on the block, a crosswalk crosses 9W south of Western Avenue in the center of the Hamlet area, roughly from Key Bank to Pizza Town.

Figure 4: Non-signalized crosswalk with pedestrian crossing signs on 9W northbound at Dubois St., looking north

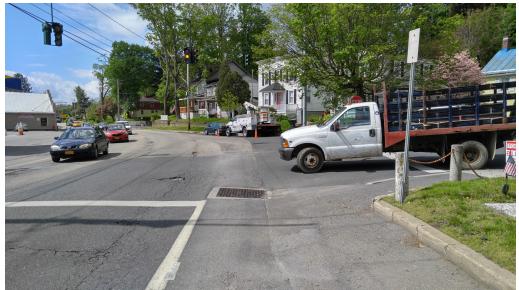
Figure 5: Signalized intersection of King Street at 9W southbound where sidewalk and shoulder merge, looking south

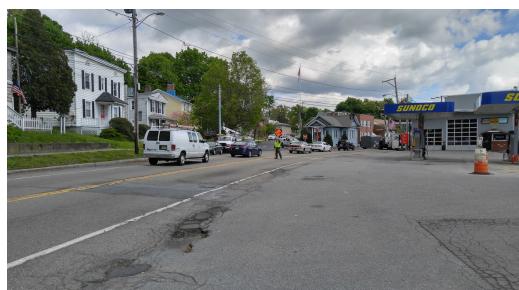
On the east side of Route 9W at the Sunoco gas station in Marlboro, the shoulder is approximately seven (7') feet wide and the gas station frontage is fully paved with unrestricted vehicular access (Fig. 6). A sidewalk begins north of the auto body garage and extends along the commercial buildings to the north and then narrows to a few feet in width as it turns and steps down to follow the commercial streetscape across from Western Avenue (Fig 7 & 8). The shoulder and on-street parking area in this part of the Hamlet, although not differentiated or specifically marked, is approximately fourteen (14') feet wide.

Figure 6: Shoulder and paved lot at Sunoco on Route 9W northbound (east), looking north

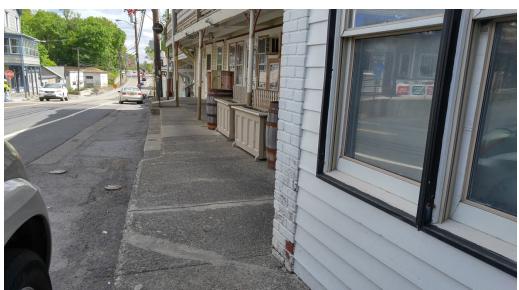
Figure 7: Sidewalk narrows around building corner at Raccoon Saloon on 9W northbound, looking north

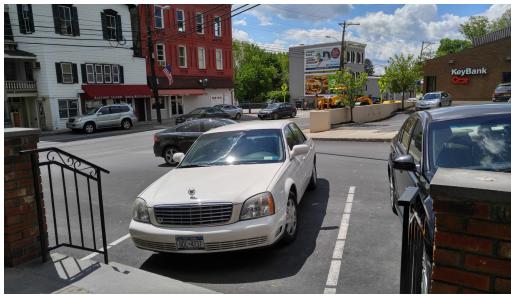
Figure 10: Stairs to sidewalk through parking stalls on northwest side of Western Ave/9W intersection, looking south

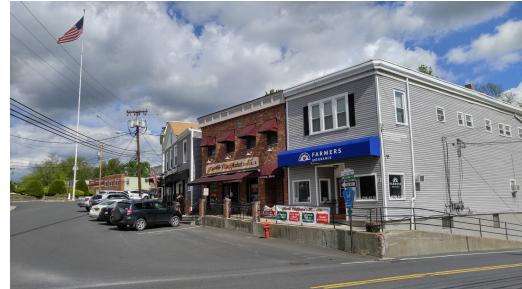
On the west side of 9W, there is no crosswalk across the Western Avenue intersection from south to north due to the sidewalk elevation sitting well above that of Route 9W on the north side of the road (Fig. 9). The sidewalk on the north side can be accessed via the on-street parking stalls on Western Avenue and is used as an outdoor seating area for adjacent businesses (Fig. 10 & 11). The sidewalk ramps down as it turns the corner around Western Avenue at Farmer's Insurance onto Route 9W (Fig. 12). A seven (7') foot shoulder borders the west side of Route 9W along the ramp.

Figure 9: Intersection of Western Ave at 9W southbound, looking northwest

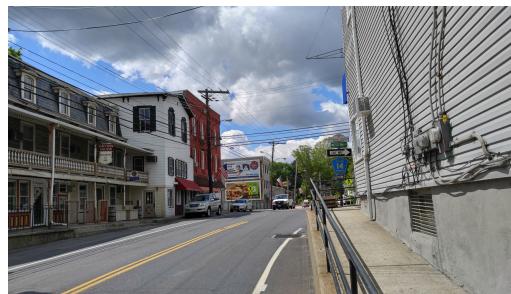
Figure 12: Sidewalk ramp and narrow shoulder on 9W southbound, looking south

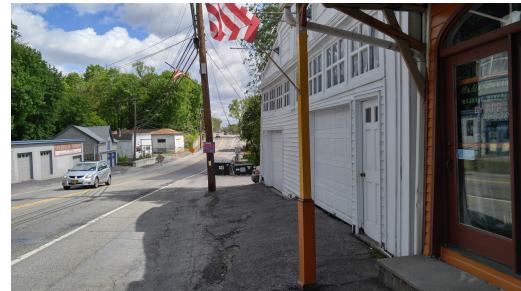
Approaching Dock Road from the south, the shoulder on the east side of 9W narrows to four (4') feet as it passes along several garages adjoining the commercial buildings lining the roadway (Fig. 13). Around Mile 0.25, to the south side of the bridge over Lattintown Creek falls, dumpsters are located just off the shoulder (Fig. 14). On the east side of the bridge, there is a three-and-a-half (3.5') foot maintained shoulder, plus seven (7') feet of additional pavement; but, it is unclear what is roadway maintained by the State versus adjoining property owners. To the north of the Lattintown

Figure 13: Garages abut pavement where sidewalk and shoulder merge together on 9W northbound, looking north

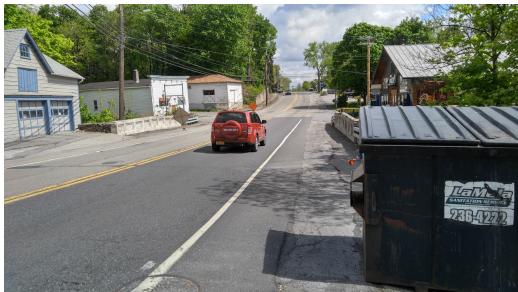
Figure 14: Dumpster along shoulder south of Lattintown Creek bridge on 9W northbound, looking north

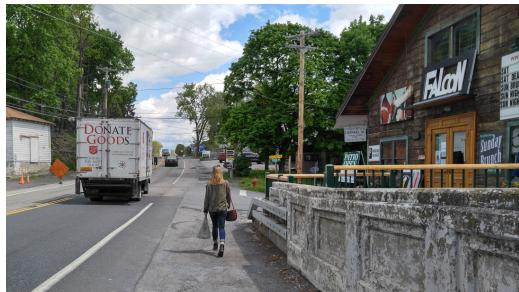
Figure 15: Pedestrian walking in shoulder over Lattintown Creek bridge in front of The Falcon on 9W northbound, looking north

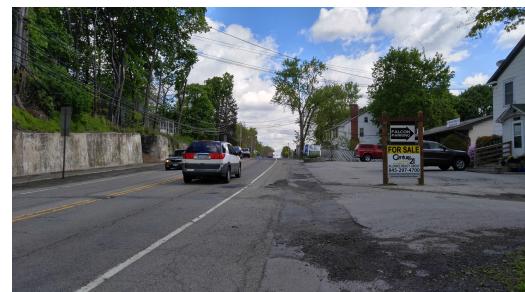
North of Dock Road, up to the billboard/Citgo gas station on the east side of 9W, the shoulder is approximately three (3') feet in width and in poor condition along the edge where it meets the parking areas of the businesses (Fig. 16) and then widens alongside the Elementary School to eight (8') feet. On the west side of 9W, north of The Falcon/Dock Road, there is a six (6') foot sidewalk in poor condition with debris, cracking, and a steep slope, bordered by a three (3') foot shoulder, also with debris. It appears that stormwater runs from a break in the retaining wall on the west side of 9W and sheet flows across the road, leaving debris (Fig. 17). The east side of the road also appears to be in poor condition due to erosion as stormwater runs downhill along Route 9W.

Figure 16: Pavement condition in shoulder on 9W northbound, looking north

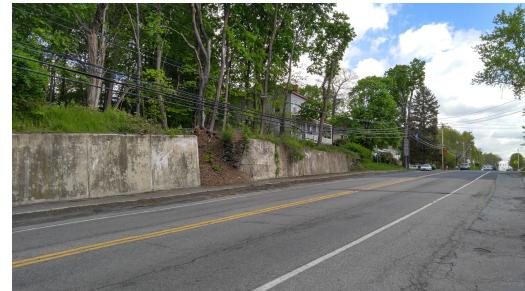
Figure 17: Break in retaining wall and sidewalk on 9W southbound, looking north

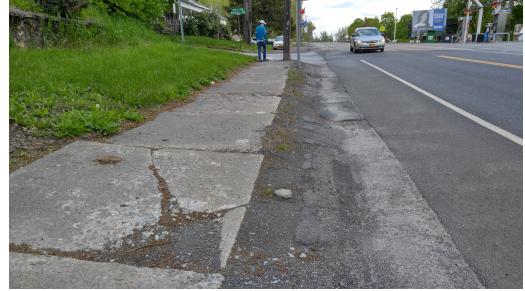
The sidewalk along the west side of Route 9W north of Marlboro hamlet continues up to Birdsall Avenue and is approximately four (4') feet in width and in poor condition (Fig. 18). A utility pole is placed in the sidewalk at the south side of the intersection (Fig. 19). There is no crosswalk across Birdsall Avenue and a segment of the sidewalk is missing on the north side of the intersection (Fig. 19 & 20). An asphalt sidewalk of three to four (3-4') feet in width continues from the second property north of Birdsall Avenue, in front of Marlboro Middle School, and to the school exit lane; although, the sidewalk ends before reaching the crosswalk (Fig. 21). There is also a ten (10') foot grass/gravel buffer between the sidewalk and a four (4') foot shoulder. A crosswalk crosses the Middle School exit road and has a detectable warning surface (DWS) only on the north side, connecting to a sidewalk five (5') feet in width that is in good condition,

Figure 18: Sidewalk and shoulder conditions on 9W southbound at Birdsall Ave, looking north

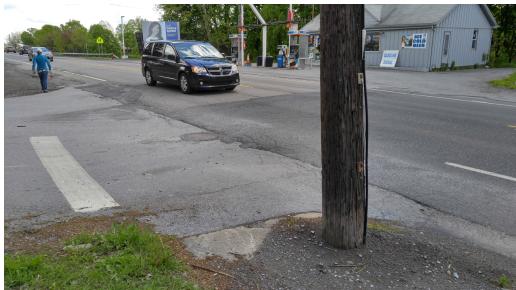
Figure 19: Deteriorated sidewalk with utility pole on 9W southbound at Birdsall Ave, looking north

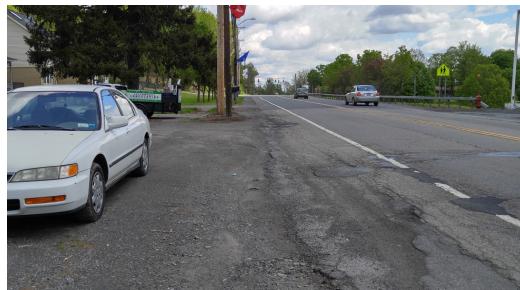
Figure 20: Broken pavement and extended shoulder/paved front yard used as parking north of Birdsall Ave. Sidewalk reappears after second house north of Birdsall Ave on 9W southbound

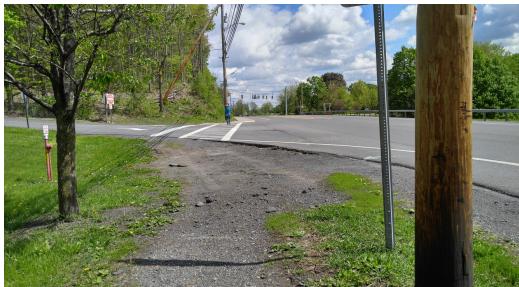
Figure 21: Asphalt sidewalk becomes gravel at south side of Middle School exit road on 9W southbound, looking north

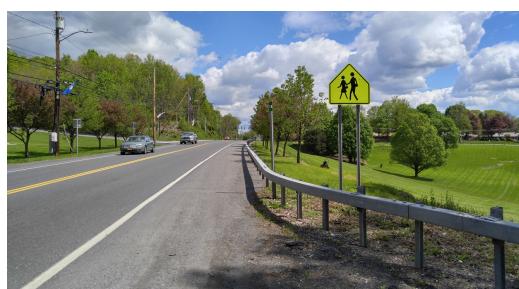
Figure 24: 8-foot shoulder in good condition along Elementary School frontage on 9W northbound, looking north

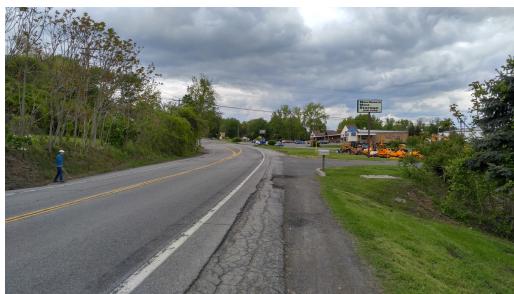
Figure 26: Shoulder in very poor condition along 9W northbound near Bixby Lane, looking north

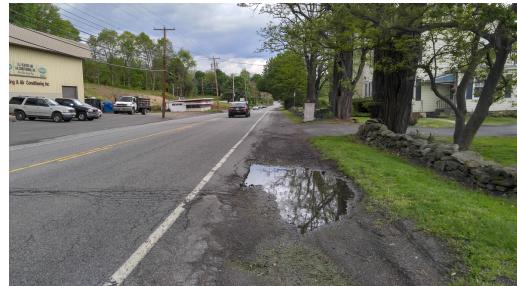
Figure 25: Unmaintained shoulder on 9W northbound between Hudson Banks and James Street, looking north

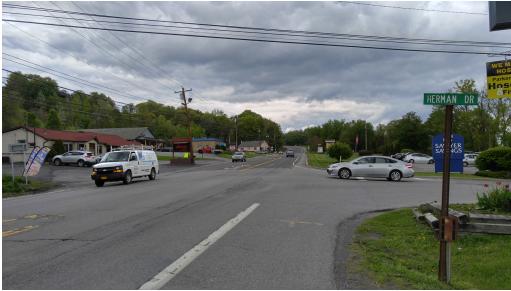
Figure 27: Pavement in fair condition at intersection of Herman Drive and 9W northbound, looking north

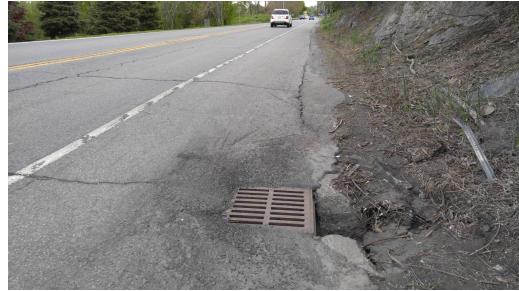
The shoulder along both sides of Route 9W from Young Avenue up to Purdy Avenue (west)/Hudson Banks (east) is approximately eight (8') feet in width and in good condition. North of Hudson Banks, the shoulder narrows to around five (5') feet and then becomes nine to ten (9-10') feet, with three to four (3-4') feet maintained and six (6') feet of gravel. Beyond the 40mph sign (approximately several hundred feet), the shoulder condition deteriorates and there are approximately four (4') feet of maintained shoulder adjacent to around eight (8') feet of broken pavement/gravel and potholes (Fig. 25). The shoulder varies along the east side from nine (9') feet at the southern end to five (5') feet at Riverview Drive and barely existent in between. It is mostly in poor condition/unmaintained with large potholes and broken up areas in this section. The west side of 9W up to James Street has an eight to eight-and-a-half (8-8.5') foot wide shoulder in fair condition, of which five (5') feet are paved. The property frontage along the west side is entirely paved with one large open curb cut/no access controls. The shoulder narrows slightly between James Street and Warren Street and an exposed grate and drainage pipe indicates deterioration due to drainage along the west side of the roadway (Fig. 28).

Figure 28: Pavement in fair condition; drainage grate in shoulder on 9W southbound south of Bixby Lane, looking south

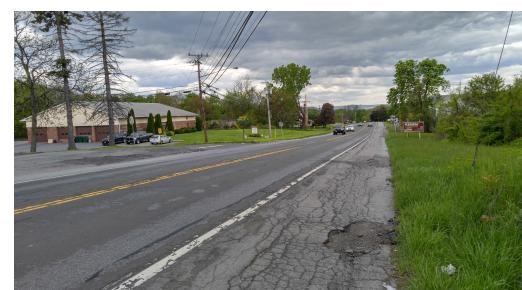
North of Hudson Bluff Drive, there is considerably less traffic and development until Lyons Lane/Rivercrest Lane. There are no sidewalks, but the shoulders on both sides of Route 9W are in fair condition, with some areas of broken pavement north of Hudson Bluff Drive (Fig. 31). On the west side, the shoulder is approximately eight (8') feet wide to Mile 2.00 approaching Lyons Lane, and then narrows to three (3') feet to accommodate an area of crosshatching at the southern approach to Lyons Lane (Fig. 32). The east shoulder is between six and eight (6-8') feet in width up to Rivercrest Lane, with some minor edge cracking and potholes.

Figure 31: Some cracking and broken pavement north of Hudson Bluff Drive on 9W southbound, looking south

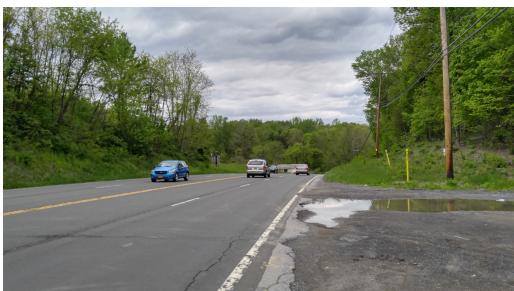
Figure 36: High-speed area with no shoulders, looking north across from Ship Lantern Inn

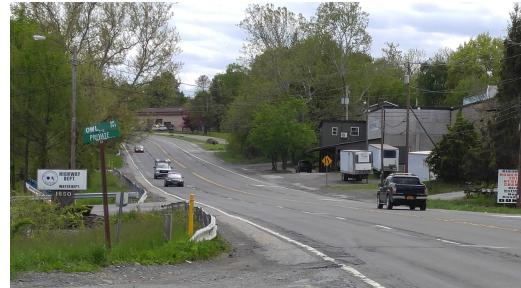
Figure 34: Narrow shoulder along 9W northbound, looking south at Owl Drive

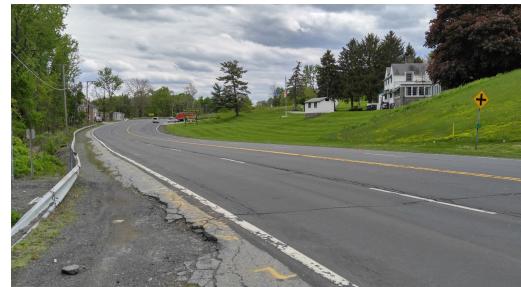
South Road at 9W (Fig. 34). There is a large area of ponding on the east side of the road halfway between Old Indian Road and Willow Tree Road at Mile 3.25 across from Ship Lantern Inn (Fig. 35 & 36).

Figure 35: Narrow shoulder in poor condition with broken pavement on 9W northbound across from Ship Lantern Inn, looking south

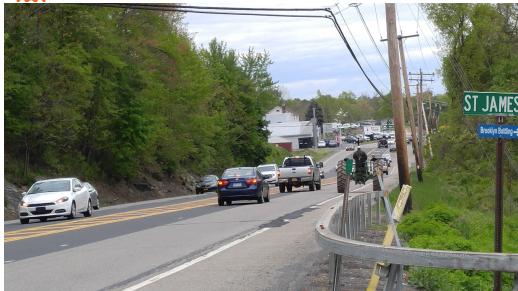
Figure 38: Slightly wider shoulder in fair condition; road narrows to one lane, shared with tractor on 9W northbound, looking north

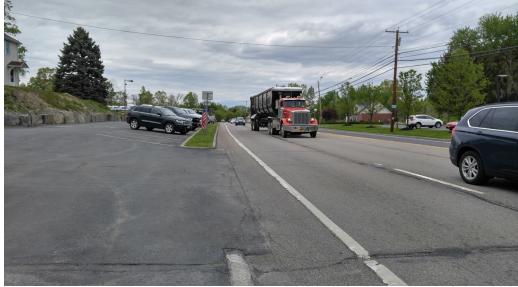
Figure 40: Young's Auto, three travel lanes and minimal shoulder on 9W southbound at Milton Turnpike, looking north

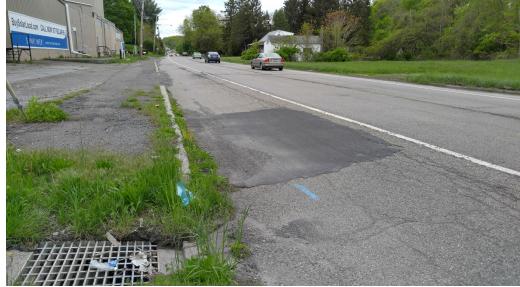
Figure 41: Wide shoulder in fair condition at Mahoney Road, looking south

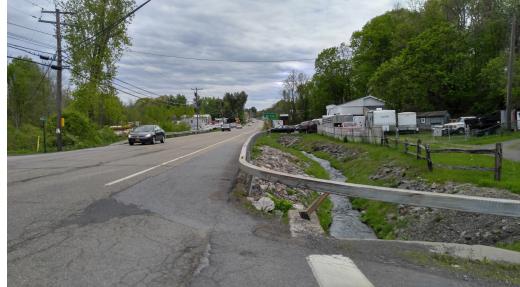
Figure 43: Shoulder in fair condition and guardrail at edge with ditch/creek below on 9W southbound at Perkinsville Road, looking south

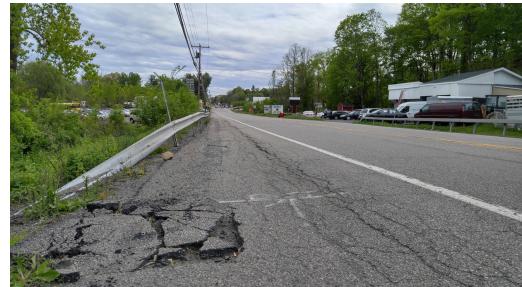
Figure 44: Severely broken pavement in shoulder on 9W northbound at Milton Road, looking south

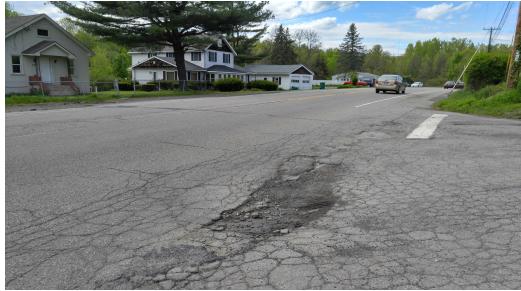
At the northern border of Marlborough with Lloyd, the shoulders are eight-and-a-half to nine (8.5-9') feet on the west side and seven-and-a-half to eight (7.5-8') feet on the east side in fair to poor condition, with some broken pavement and sloped areas that reduce the effective size of the shoulder. North of Perkinsville Road/North Road, the shoulder is ten (10') feet wide along the east side of 9W and eight-and-a-half (8.5') feet wide on the west side of the corridor and is generally in fair condition. The shoulders between Mackey Road and Bluepoint Road range from approximately seven-and-a-half (7.5') feet wide to ten-and-a-half (10.5') feet wide and are generally in fair condition, with small areas deteriorating to poor conditions (Fig. 46 & 47).

Figure 46: Moderately breaking and cracking pavement in shoulder on 9W northbound at Blue Point Road, looking north

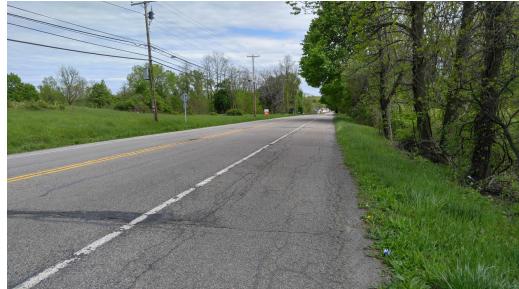
Figure 47: Wide shoulder in fair condition on 9W southbound at Blue Point Road, looking south
