**Independent Solar, LLC Section F (rev. 8/12/20)**  
**Full Environmental Assessment**

## **WETLAND AND WATERBODY DELINEATION REPORT INDEPENDENT SOLAR, LLC PROJECT**

**206 MILTON TURNPIKE  
TOWN OF MARLBOROUGH  
ULSTER COUNTY, NEW YORK**

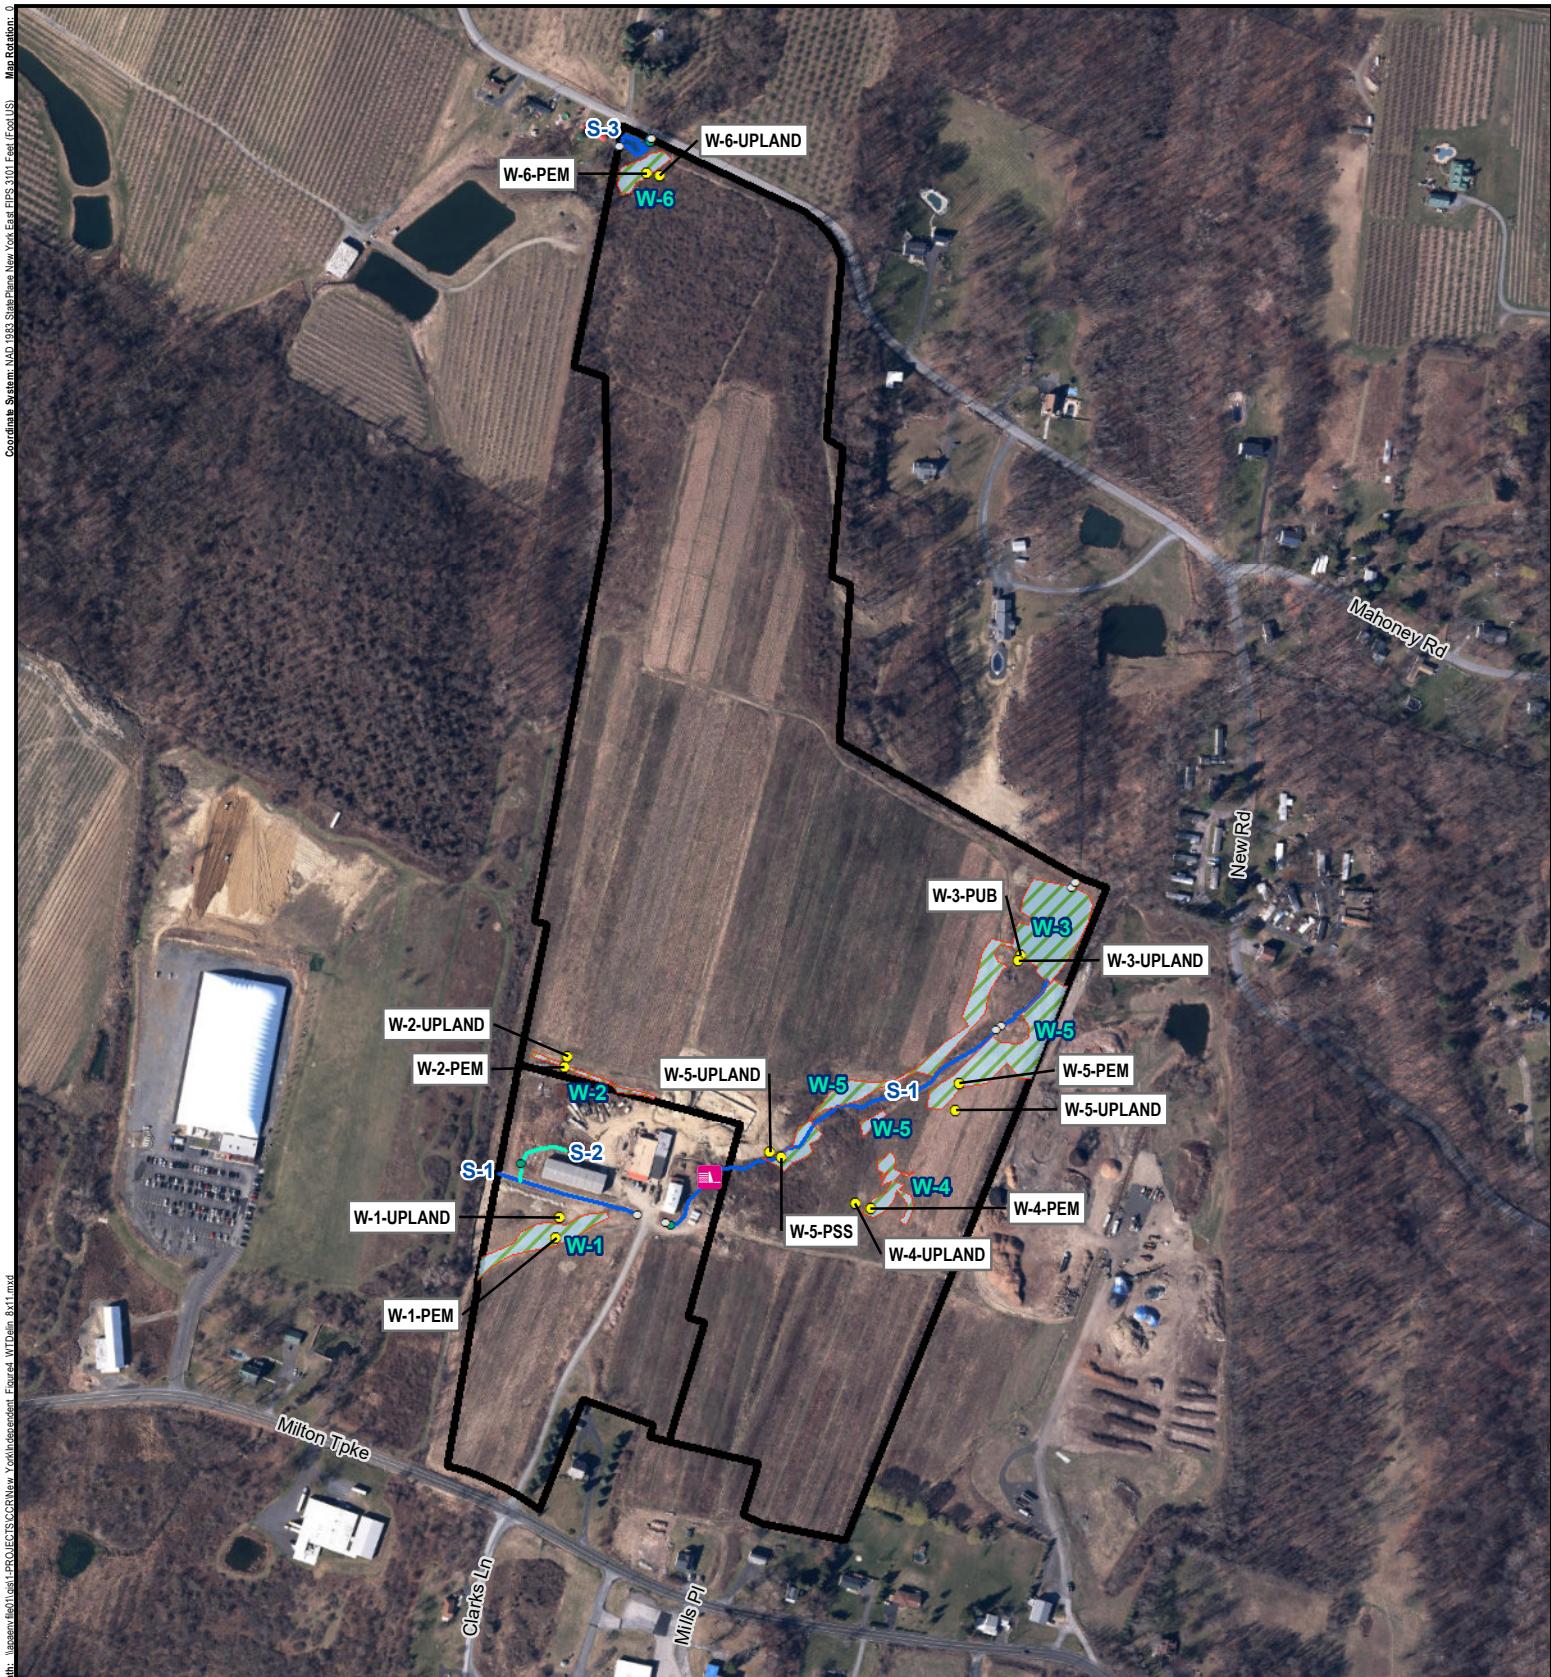
- CULVERT LOCATIONS
- DATA POINT
- STREAM PLOTS
- DAM LOCATION
- TRC DELINEATED STREAM - INTERMITTENT - USACE JURISDICTIONAL
- TRC DELINEATED STREAM - PERENNIAL - USACE JURISDICTIONAL
- TRC DELINEATED WETLAND BOUNDARY
- TRC DELINEATED WETLANDS - USACE JURISDICTIONAL
- TRC DELINEATED SURFACE WATER
- SITE LOCATION

The TRC field-delineated aquatic features within the Project Site loosely coincide with the features represented by the NWI mapping for the Project Site. However, the majority of the R4SBC riverine feature is north of where it is shown on NWI mapping. Additionally, the NWI feature labeled PEM1F was not observed during the wetland delineation. The area in which it is mapped as an NWI wetland was likely filled in the past in association with farming and agriculture activities. Farm related materials and equipment were observed at this location. Soils, hydrology, and vegetation in this location did not meet the conditional requirements of a wetland. In addition, the southern portion of R4SBC was observed to have been filled in. Water from that feature had been historically diverted to the ditch which comprises the southern portion of Waterbody S-1 and now Wetland W-1 remains where the natural stream used to traverse. Lastly, some additional aquatic features also occur within the Project Site outside of boundaries indicated by the NWI mapping, including Waterbodies S-2 and S-3, and Wetlands W-2, W-4, W-5, and W-6.

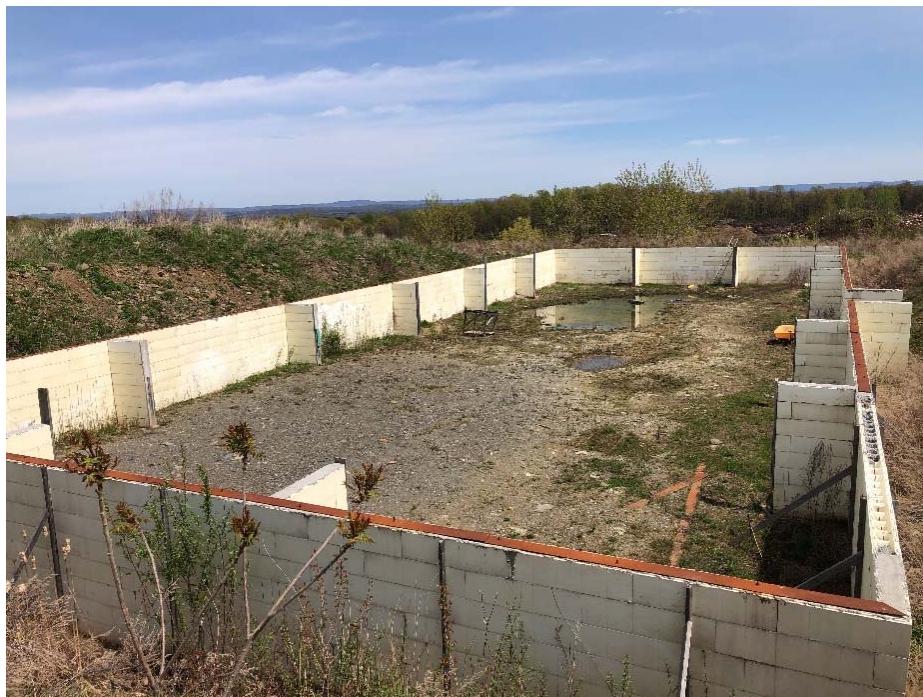
**Photograph 5.** Foundation frost walls at the Project Site, facing east. Photo taken on 4/29/19.

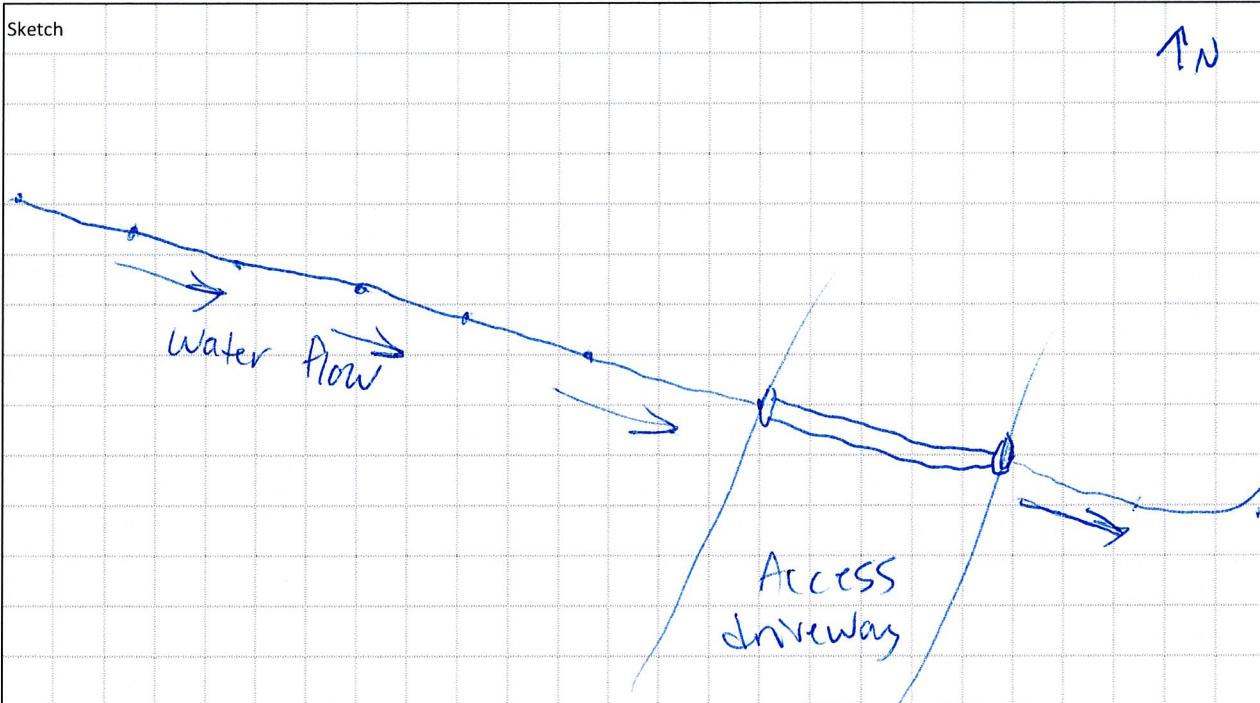
| <u>48" HDPE culvert under the access road to barn/buildings.</u> | | | | | |

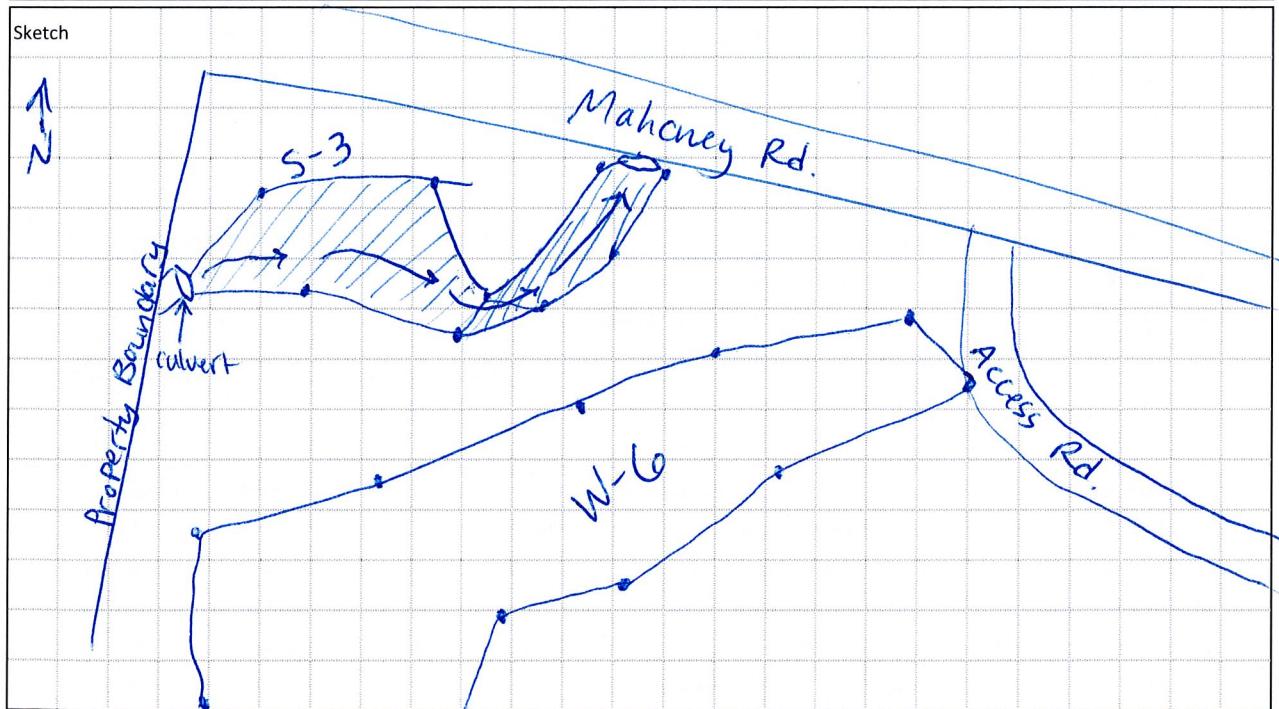
| <i>S-3 enters into an HDPE culvert under Mahaney Rd.</i> | | | | | | | |

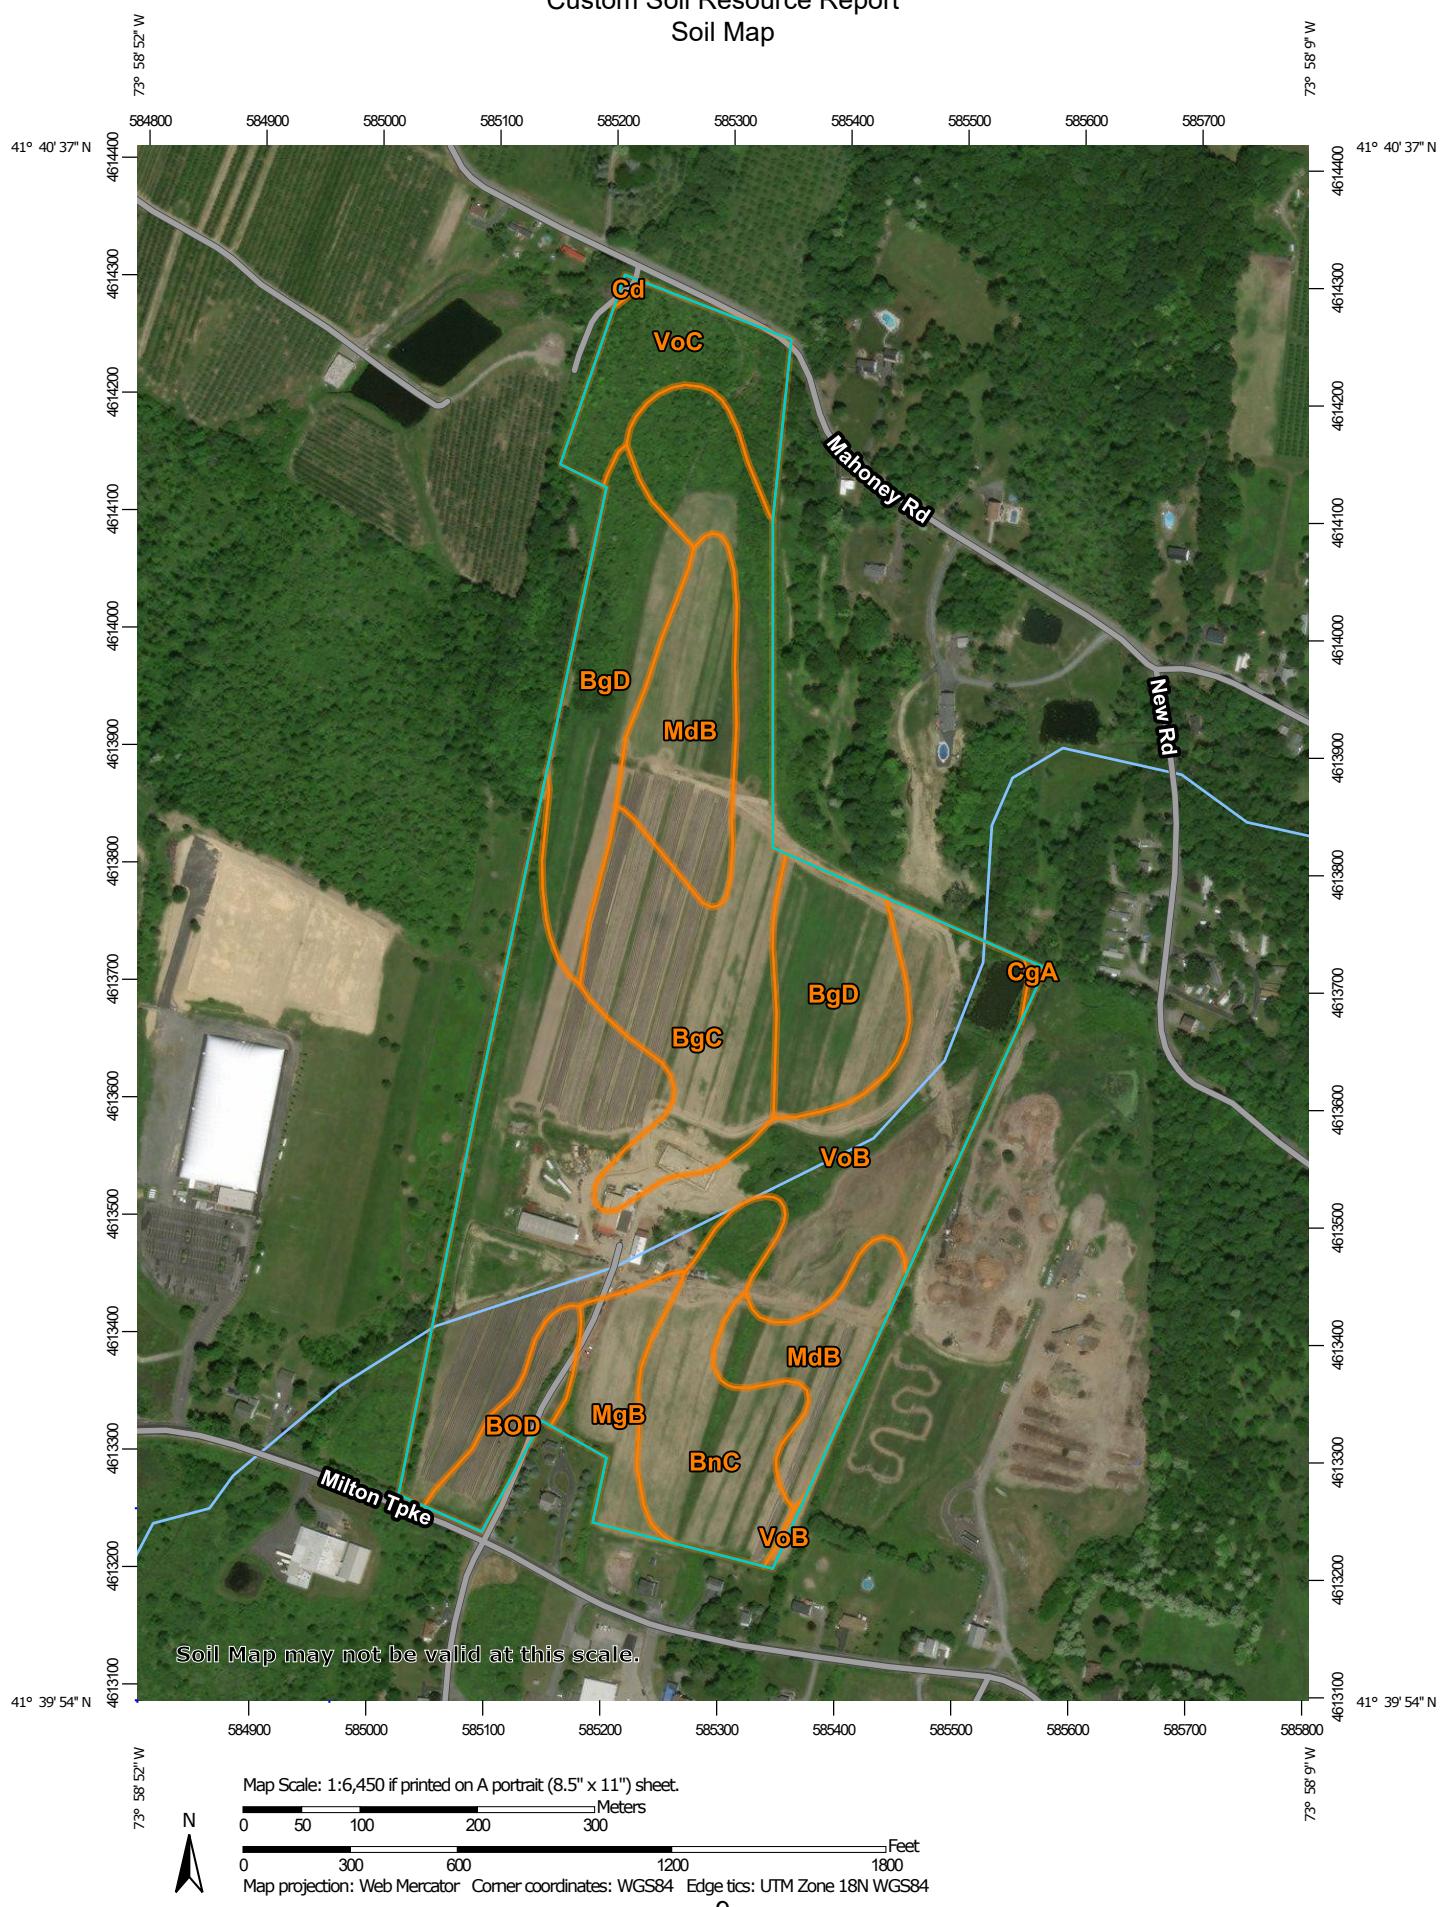
Custom Soil Resource Report  
Soil Map

The soil map section includes the soil map for the defined area of interest, a list of soil map units on the map and extent of each map unit, and cartographic symbols displayed on the map. Also presented are various metadata about data used to produce the map, and a description of each soil map unit.

Atherton silt loam (At) – A very small portion of this poorly drained soil is mapped in the easternmost portion of the Project Site. It is composed of 80 percent Atherton and similar soils and is found in depressions. The minor components of this soil unit are made up of Red hook, Raynham, Canandaigua, and Lamson soils, making up 5 percent each of the map unit. This map unit has a hydric rating of 90 percent.

Bath gravelly silt loam, 8 to 15 percent slopes (BgC) – This well drained soil is mapped in the central and northern portions of the Project Site. It is composed of 80 percent Bath and similar soils and is found on drumlinoid ridges, hills, and till plains. Lordstown soils, Manlius soils, Mardin

Bath gravelly silt loam, 15 to 25 percent slopes (BgD) – This well drained soil is mapped in the central and northern portions of the Project Site. It is composed of 75 percent Bath and similar soils and is found on hills, till plains, and drumlinoid ridges. Lordstown soils, Manlius soils, Mardin soils, Rock outcrops, and Volusia soils make up 5 percent each of the map unit. This map unit has a hydric rating of 0 percent.

Bath-Nassau complex, 8 to 25 percent slopes (BnC) – This soil complex is mapped in the southern portion of the Project Site. It is composed of 50 percent Bath (a well drained soil) and similar soils and is found on hills, till plains, and drumlinoid ridges. It is also composed of 30 percent Nassau (a somewhat excessively drained soil) and similar soils and is found on benches, ridges, and till plains. Cambridge soils, Manlius soils, Volusia soils, and Hudson soils make up 5 percent each of the map unit. This map unit has a hydric rating of 0 percent.

Bath-Nassau-Rock outcrop complex, hilly (BOD) – This soil complex is mapped in the southern portion of the Project Site. It is composed of 40 percent Bath (a well drained soil) and similar soils and is found on hills, till plains, and drumlinoid ridges. It is also comprised of 25 percent Nassau (a somewhat excessively drained soil) and similar soils, and is found on benches, ridges, and till plains. Rock outcrops comprises 15 percent of the map unit as well. Hudson soils, Manlius soils, Mardin soils, and Volusia soils make up 5 percent each of the map unit. This map unit has a hydric rating of 0 percent.

Canandaigua silt loam, till substratum (Cd) – A small portion of this very poorly drained soil is mapped in the northern portion of the Project Site. It is composed of 80 percent Canandaigua and similar soils and is found in depressions. Raynham, Lamson, Lyons, and Atherton soils make up 5 percent each of the map unit as the minor components. This map unit has a hydric rating of 95 percent.

Castile gravelly silt loam, 0 to 3 percent slopes (CgA) – A small portion of this moderately well drained soil is mapped in the easternmost portion of the Project Site. It is composed of 80 percent Castile and similar soils and is found in valley trains and terraces. Chenango soils, Red hook soils, Tunkhannock soils, and Hoosic soils make up 5 percent each of the map unit. This map unit has a hydric rating of 0 percent.

Mardin gravelly silt loam, 3 to 8 percent slopes (MdB) – This moderately well drained soil is mapped in the southeastern portion and north central portion of the Project Site. It is composed of 85 percent Mardin and similar soils and is found on hills and mountains. Bath soils, Volusia soils, and Lordstown soils make up 5 percent each of the map unit. This map unit has a hydric rating of 0 percent.

Volusia gravelly silt loam, 3 to 8 percent slopes (VoB) – This somewhat poorly drained soil is mapped in the southern and central portions of the Project Site. It is composed of 90 percent Volusia and similar soils and is found on hills and mountains. Mardin soils, found on hills and mountains, and Chippewa soils, found in depressions, make up 5 percent each of the map unit. This map unit has a hydric rating of 5 percent.

Volusia gravelly silt loam, 8 to 15 percent slopes (VoC) – This somewhat poorly drained soil is mapped in the northern portion of the Project Site. It is composed of 90 percent Volusia and similar soils and is found on hills and mountains. Mardin soils, found on hills and mountains, make up 6 percent of the map unit. Chippewa soils, found in depressions, make up 4 percent of the map unit. This map unit has a hydric rating of 4 percent.
