Re: Due Diligence Wetland & Watercourse Delineation Report
Proposed Residential Project

Proposed Residential Site
20578.01
November 15, 2021
Page 2

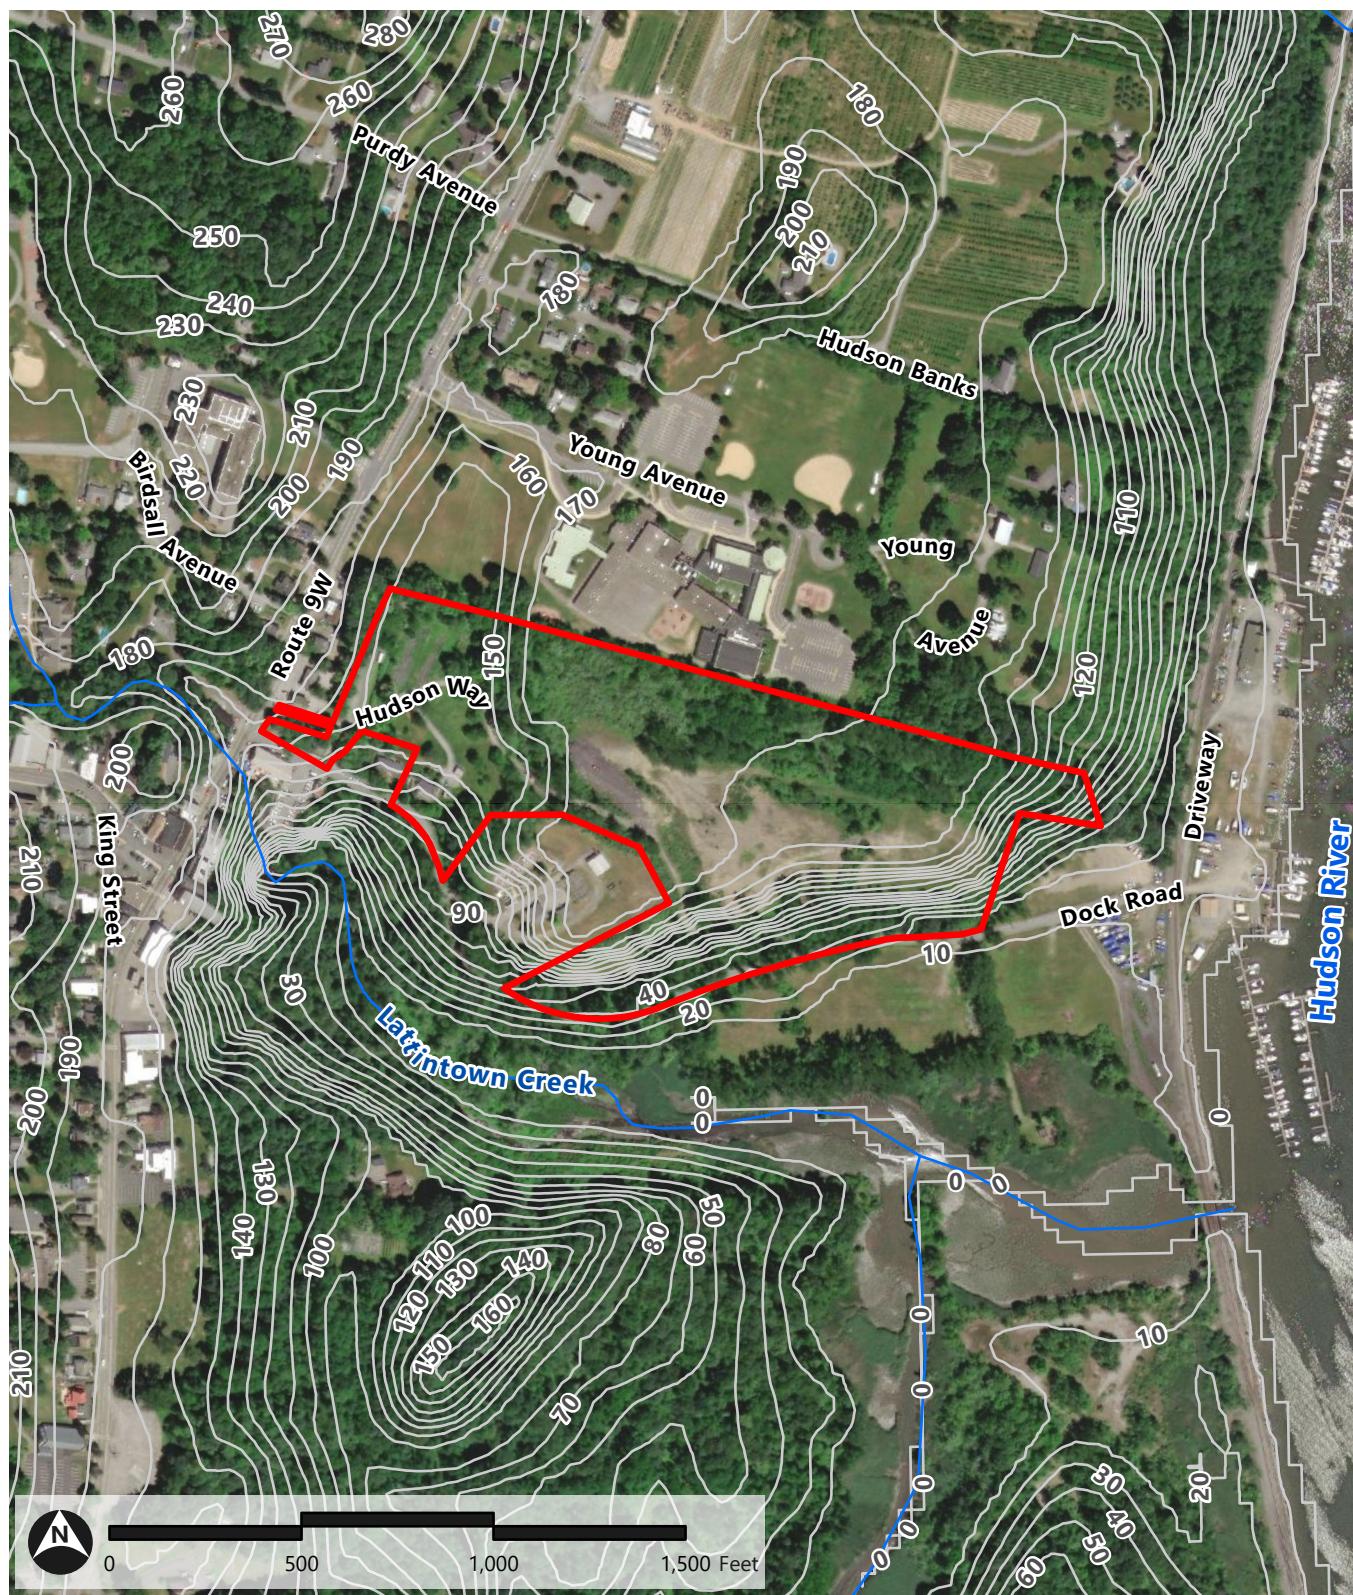
Figure 2: Site Topographic Map

The site is located at 8 Hudson Way, Marlboro New York and is bounded to the north by an elementary school, to the east by Old Dock Road and the Hudson River, and to the south and west by Dock Road and a vegetated coastal marsh environment (Figures 1 and 2). The site is primarily undeveloped, consisting of vegetated steep slopes, a gravel parking lot and access roads, and an open gravel/sand field. Elevations onsite vary from 170ft along the northern border, and 20ft at the southern border. The NRCS Web Soil Survey mapper identifies the Raynham silt loam soil unit, located on the northwestern corner of the site, as hydric and poorly drained (Figure 3).

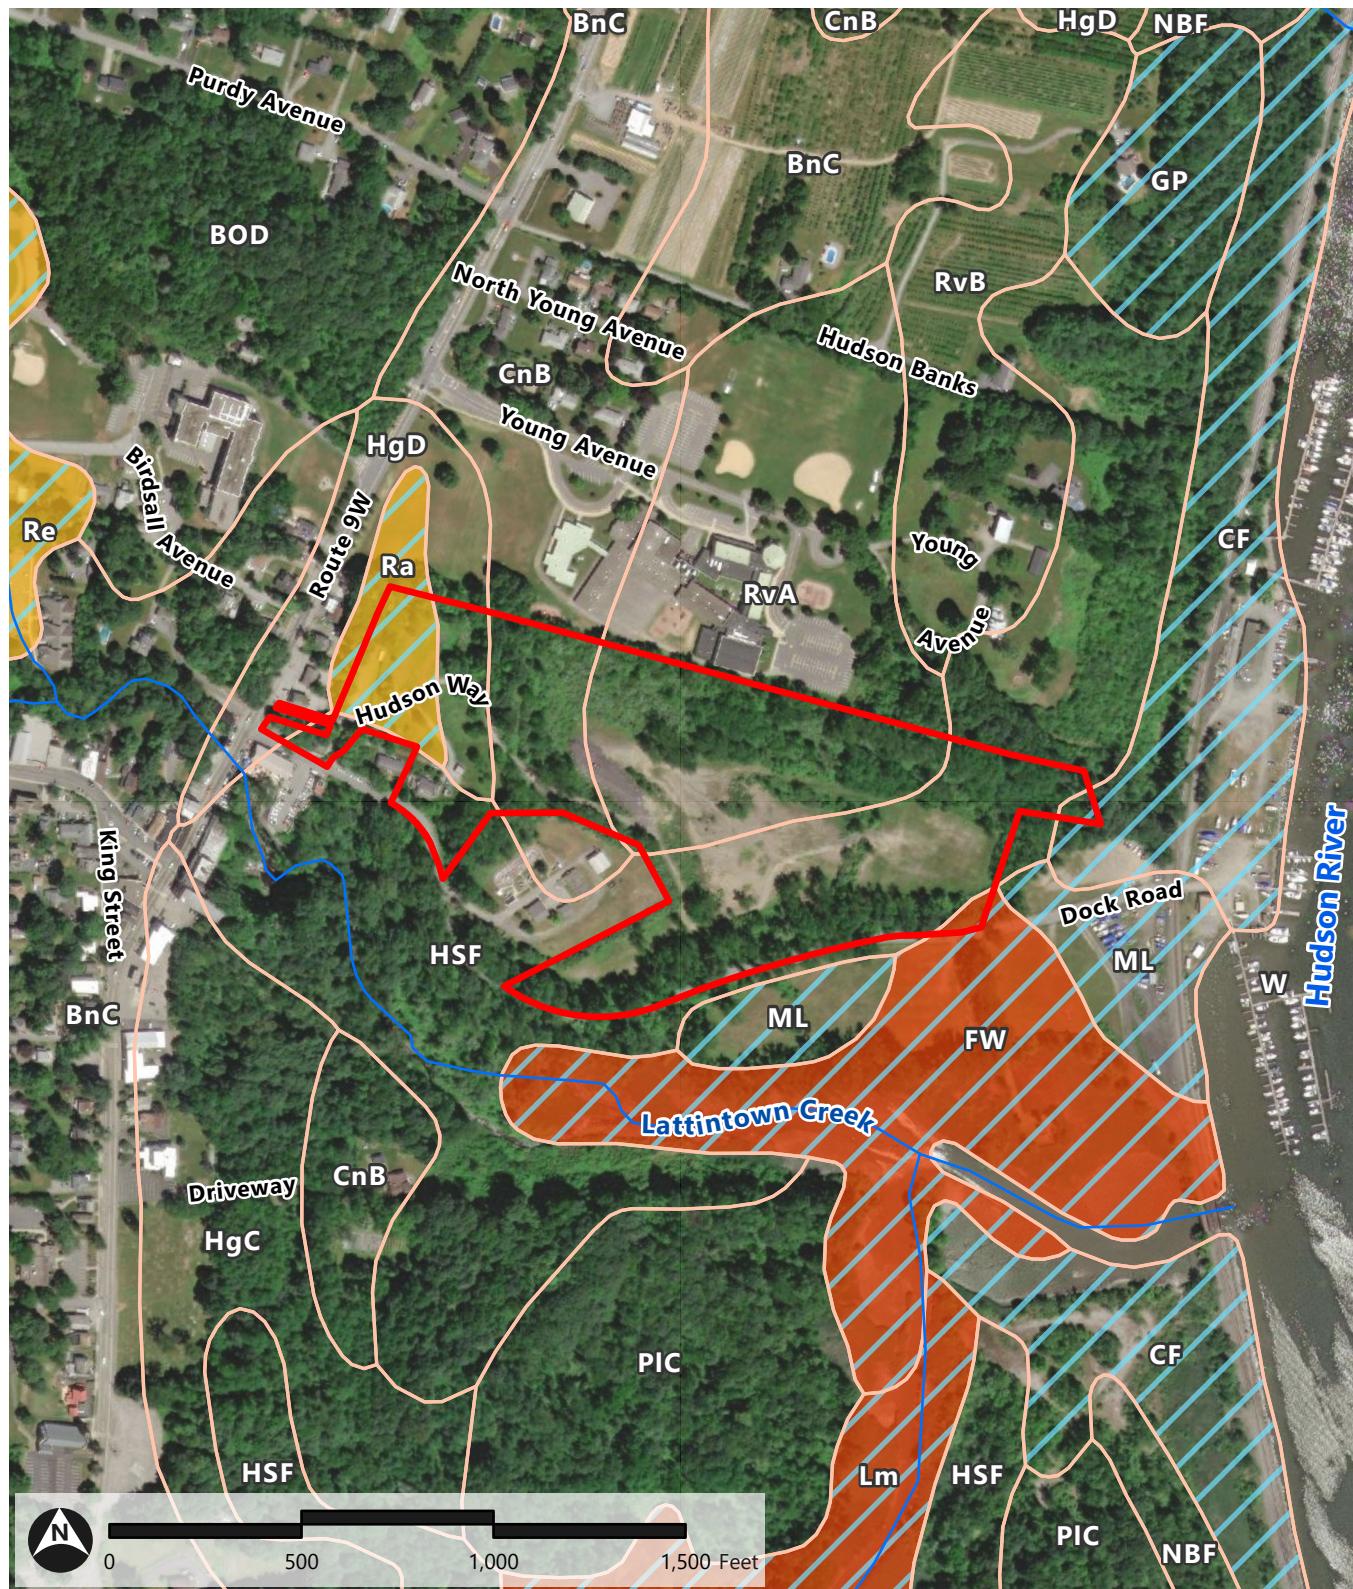
Figure 3: NRCS Soils Map

Note, Figure 3 does identify the NYSDEC's 100ft Wetland Check Zone to be onsite. New York's freshwater wetlands database only shows the approximate location of actual wetland areas. Therefore, the "Check Zone" is an area around the mapped wetland in which the actual wetland may occur and is recommended by the NYSDEC to be field evaluated. Based on the November site visit, the portion of the site within the mapped Check Zone is an extremely steep slope, with Dock Road at the toe of slope. No wetlands were observed on this slope or at the toe of slope.

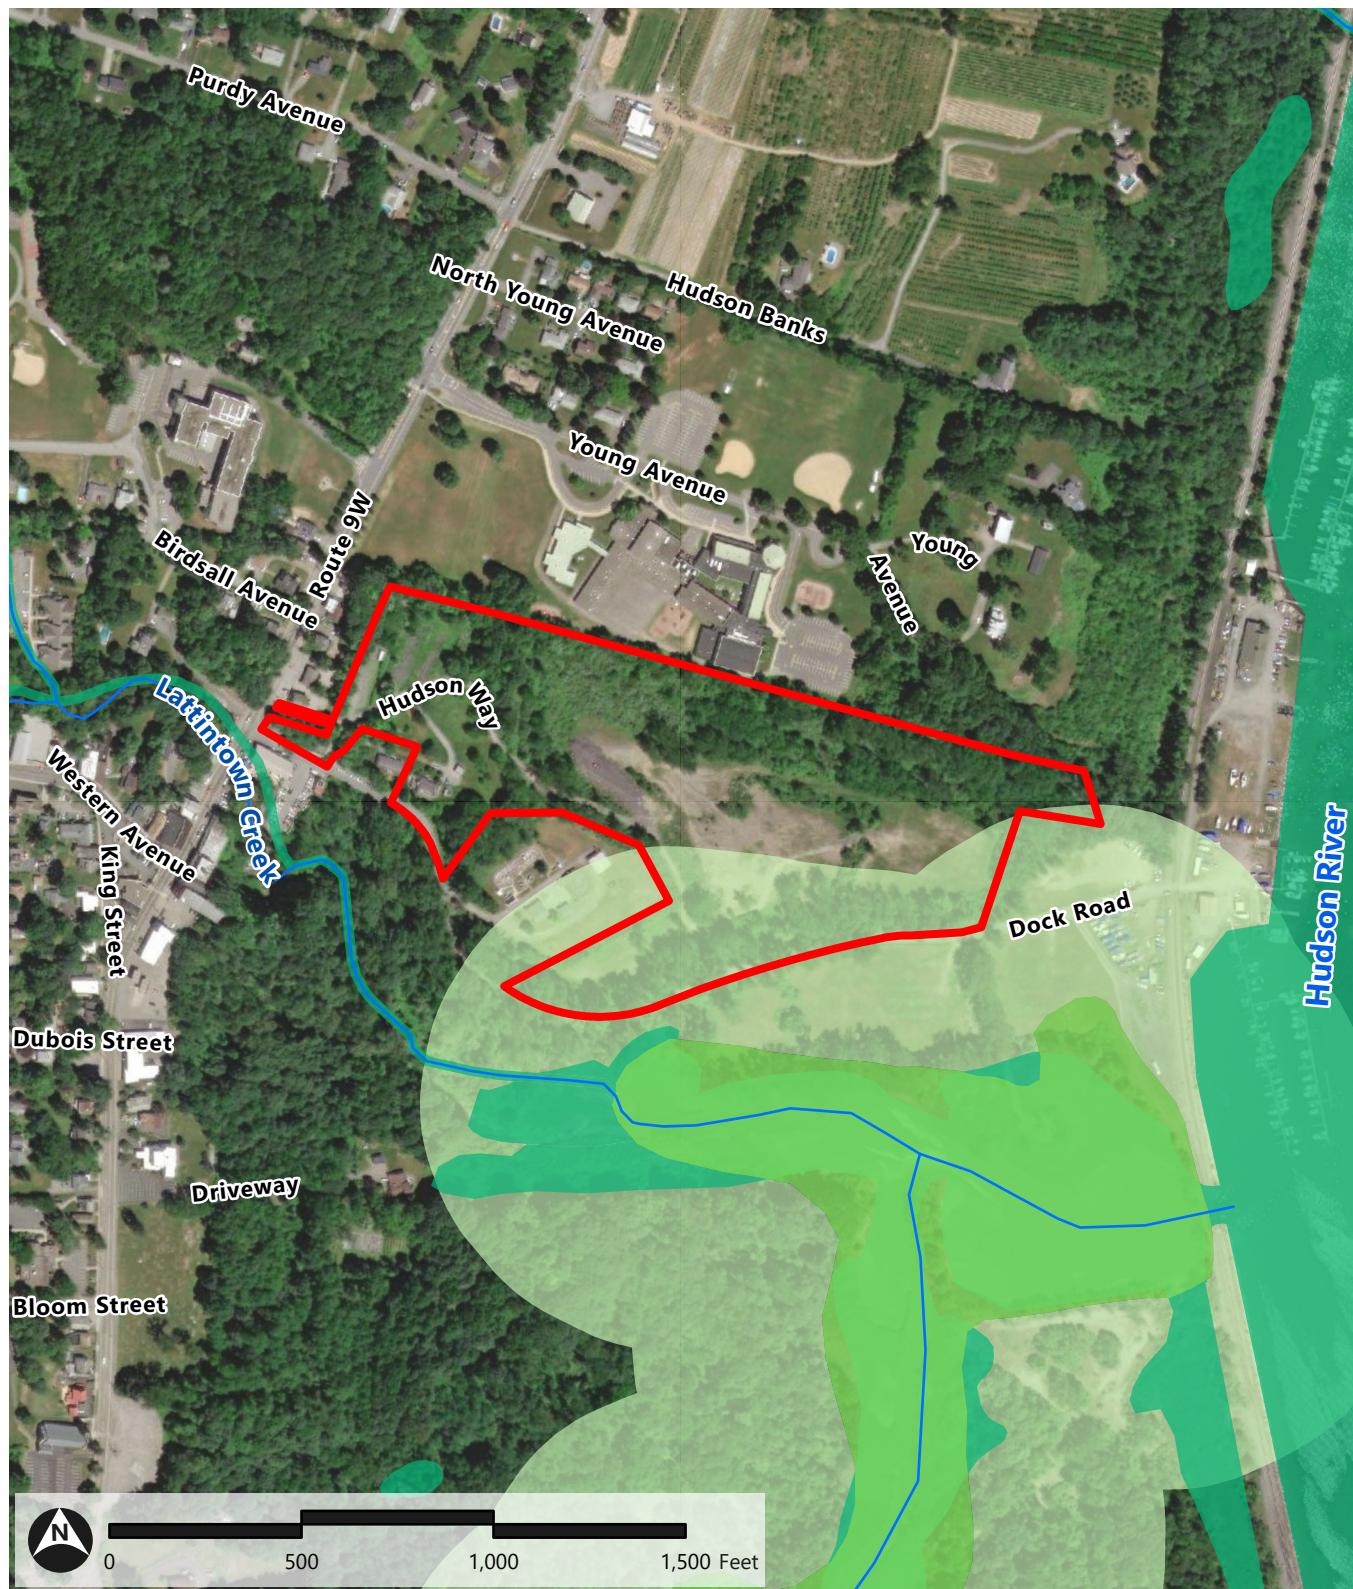
Figure 4: NWI and State Wetlands Map

No watercourses are mapped within the Project site¹ and the NWI and NYSDEC do not identify any mapped wetland resources onsite (Figure 4).

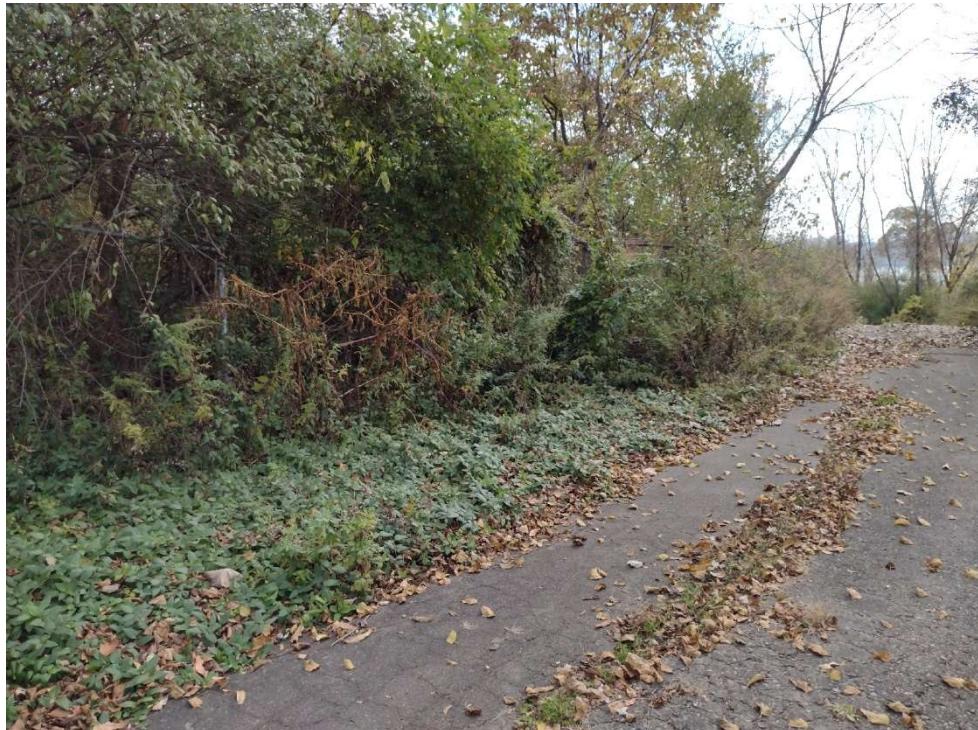
Photograph Two: Paved access road that bisects the site. A chain linked fence is present, but it dilapidated and overgrown by vegetation.

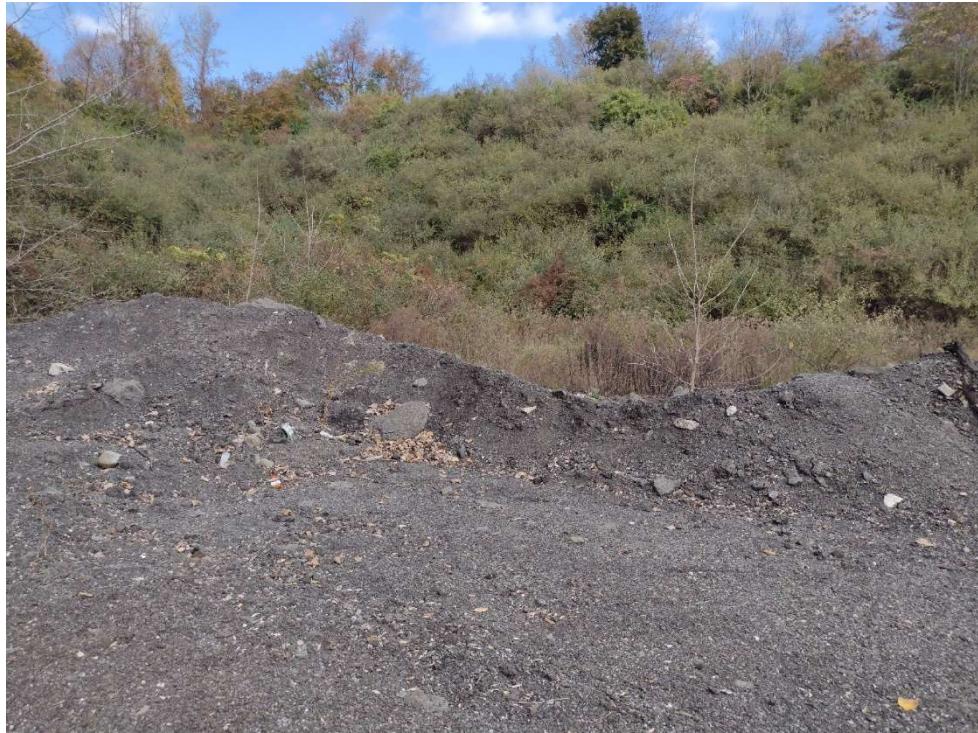
Photograph Three: Heavily vegetated steep slopes near the center of the site with gravel deposits at the toe of slope.

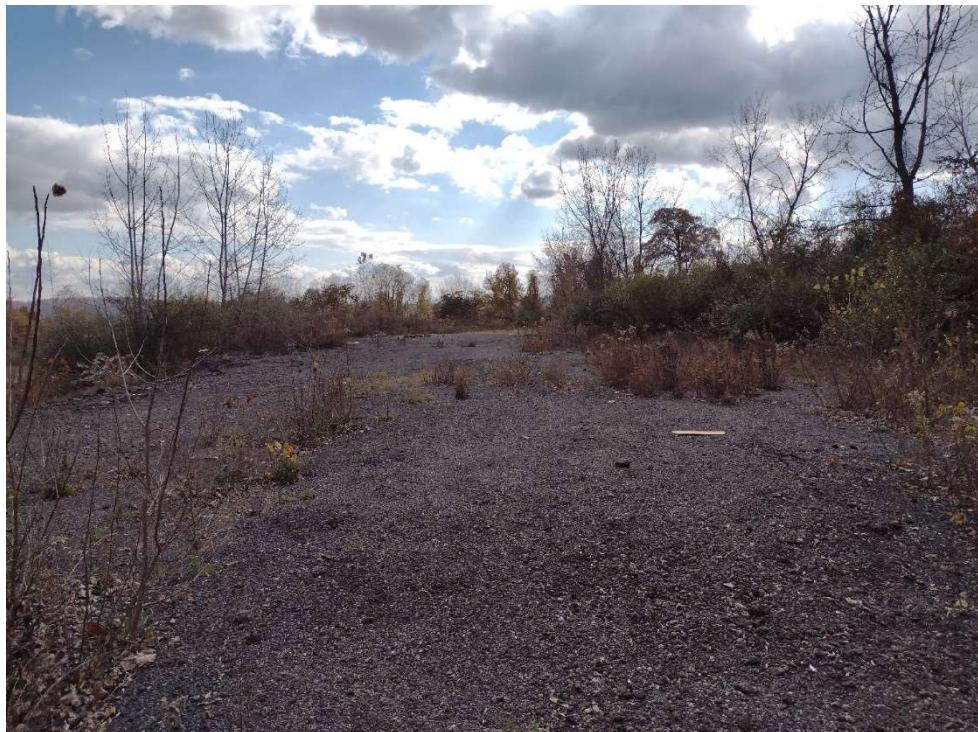
Photograph Four: Gravel/sandy open area at the center of the site adjacent to the vegetated steep slope.

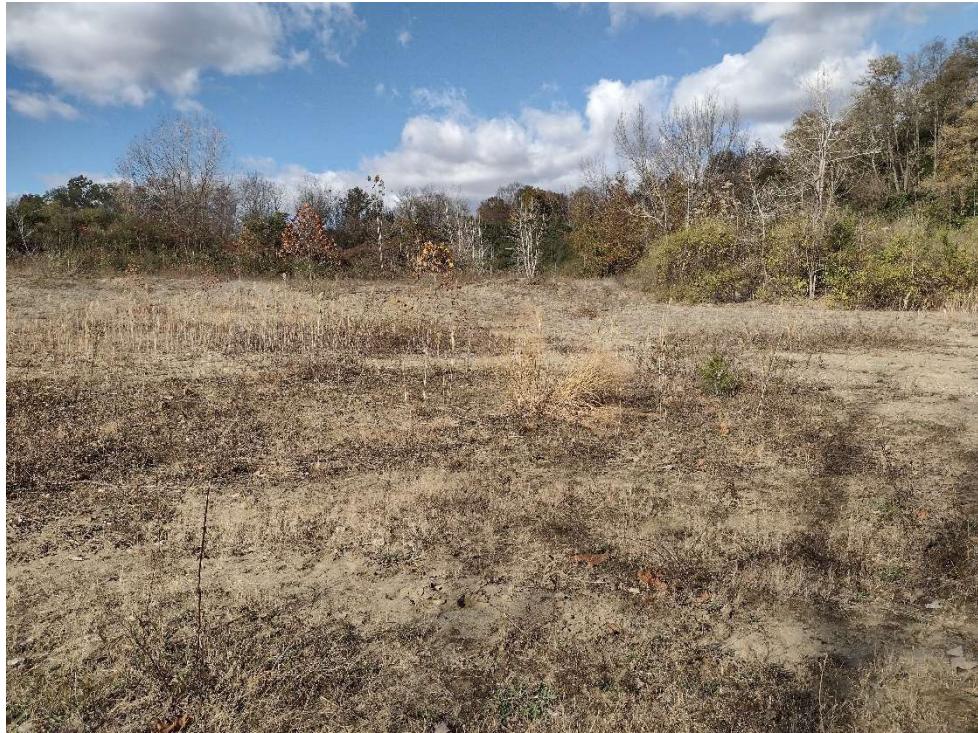
Photograph Five: The gravel/sandy open area transitions to an open field on which sand has been deposited.

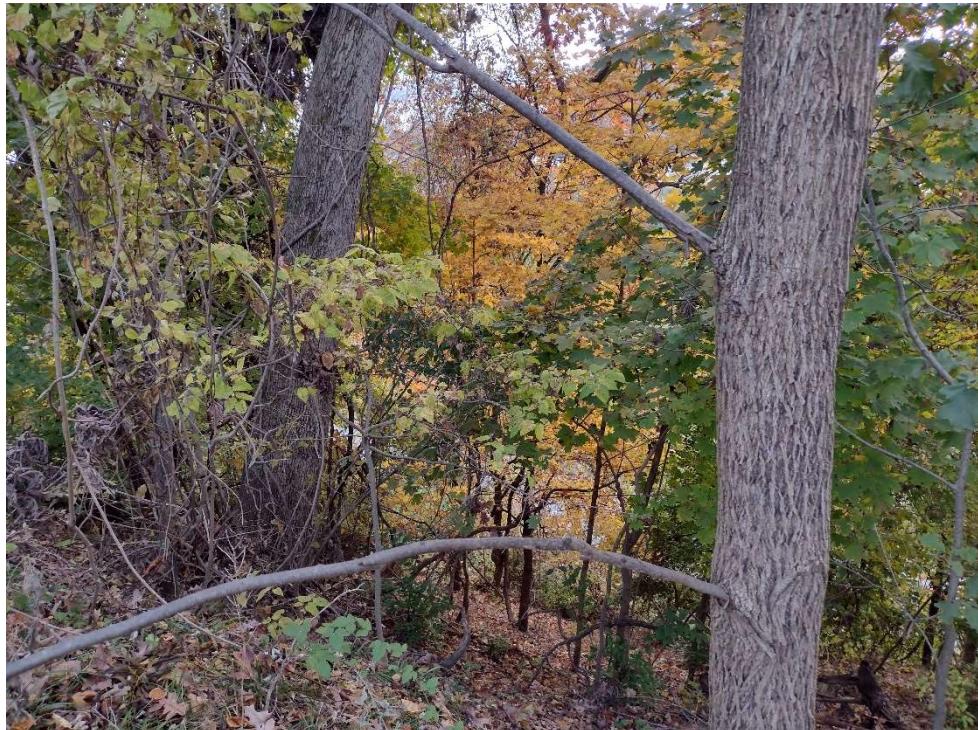
Photograph Six: Another steep slope exists on the eastern boundary of the site, adjacent to Dock Road.
