EXISTING CONDITION
Photo 3: Milton Turnpike near #170

SIMULATED CONDITION
Photo 3: Milton Turnpike near #170
Distance to project: 710 Feet

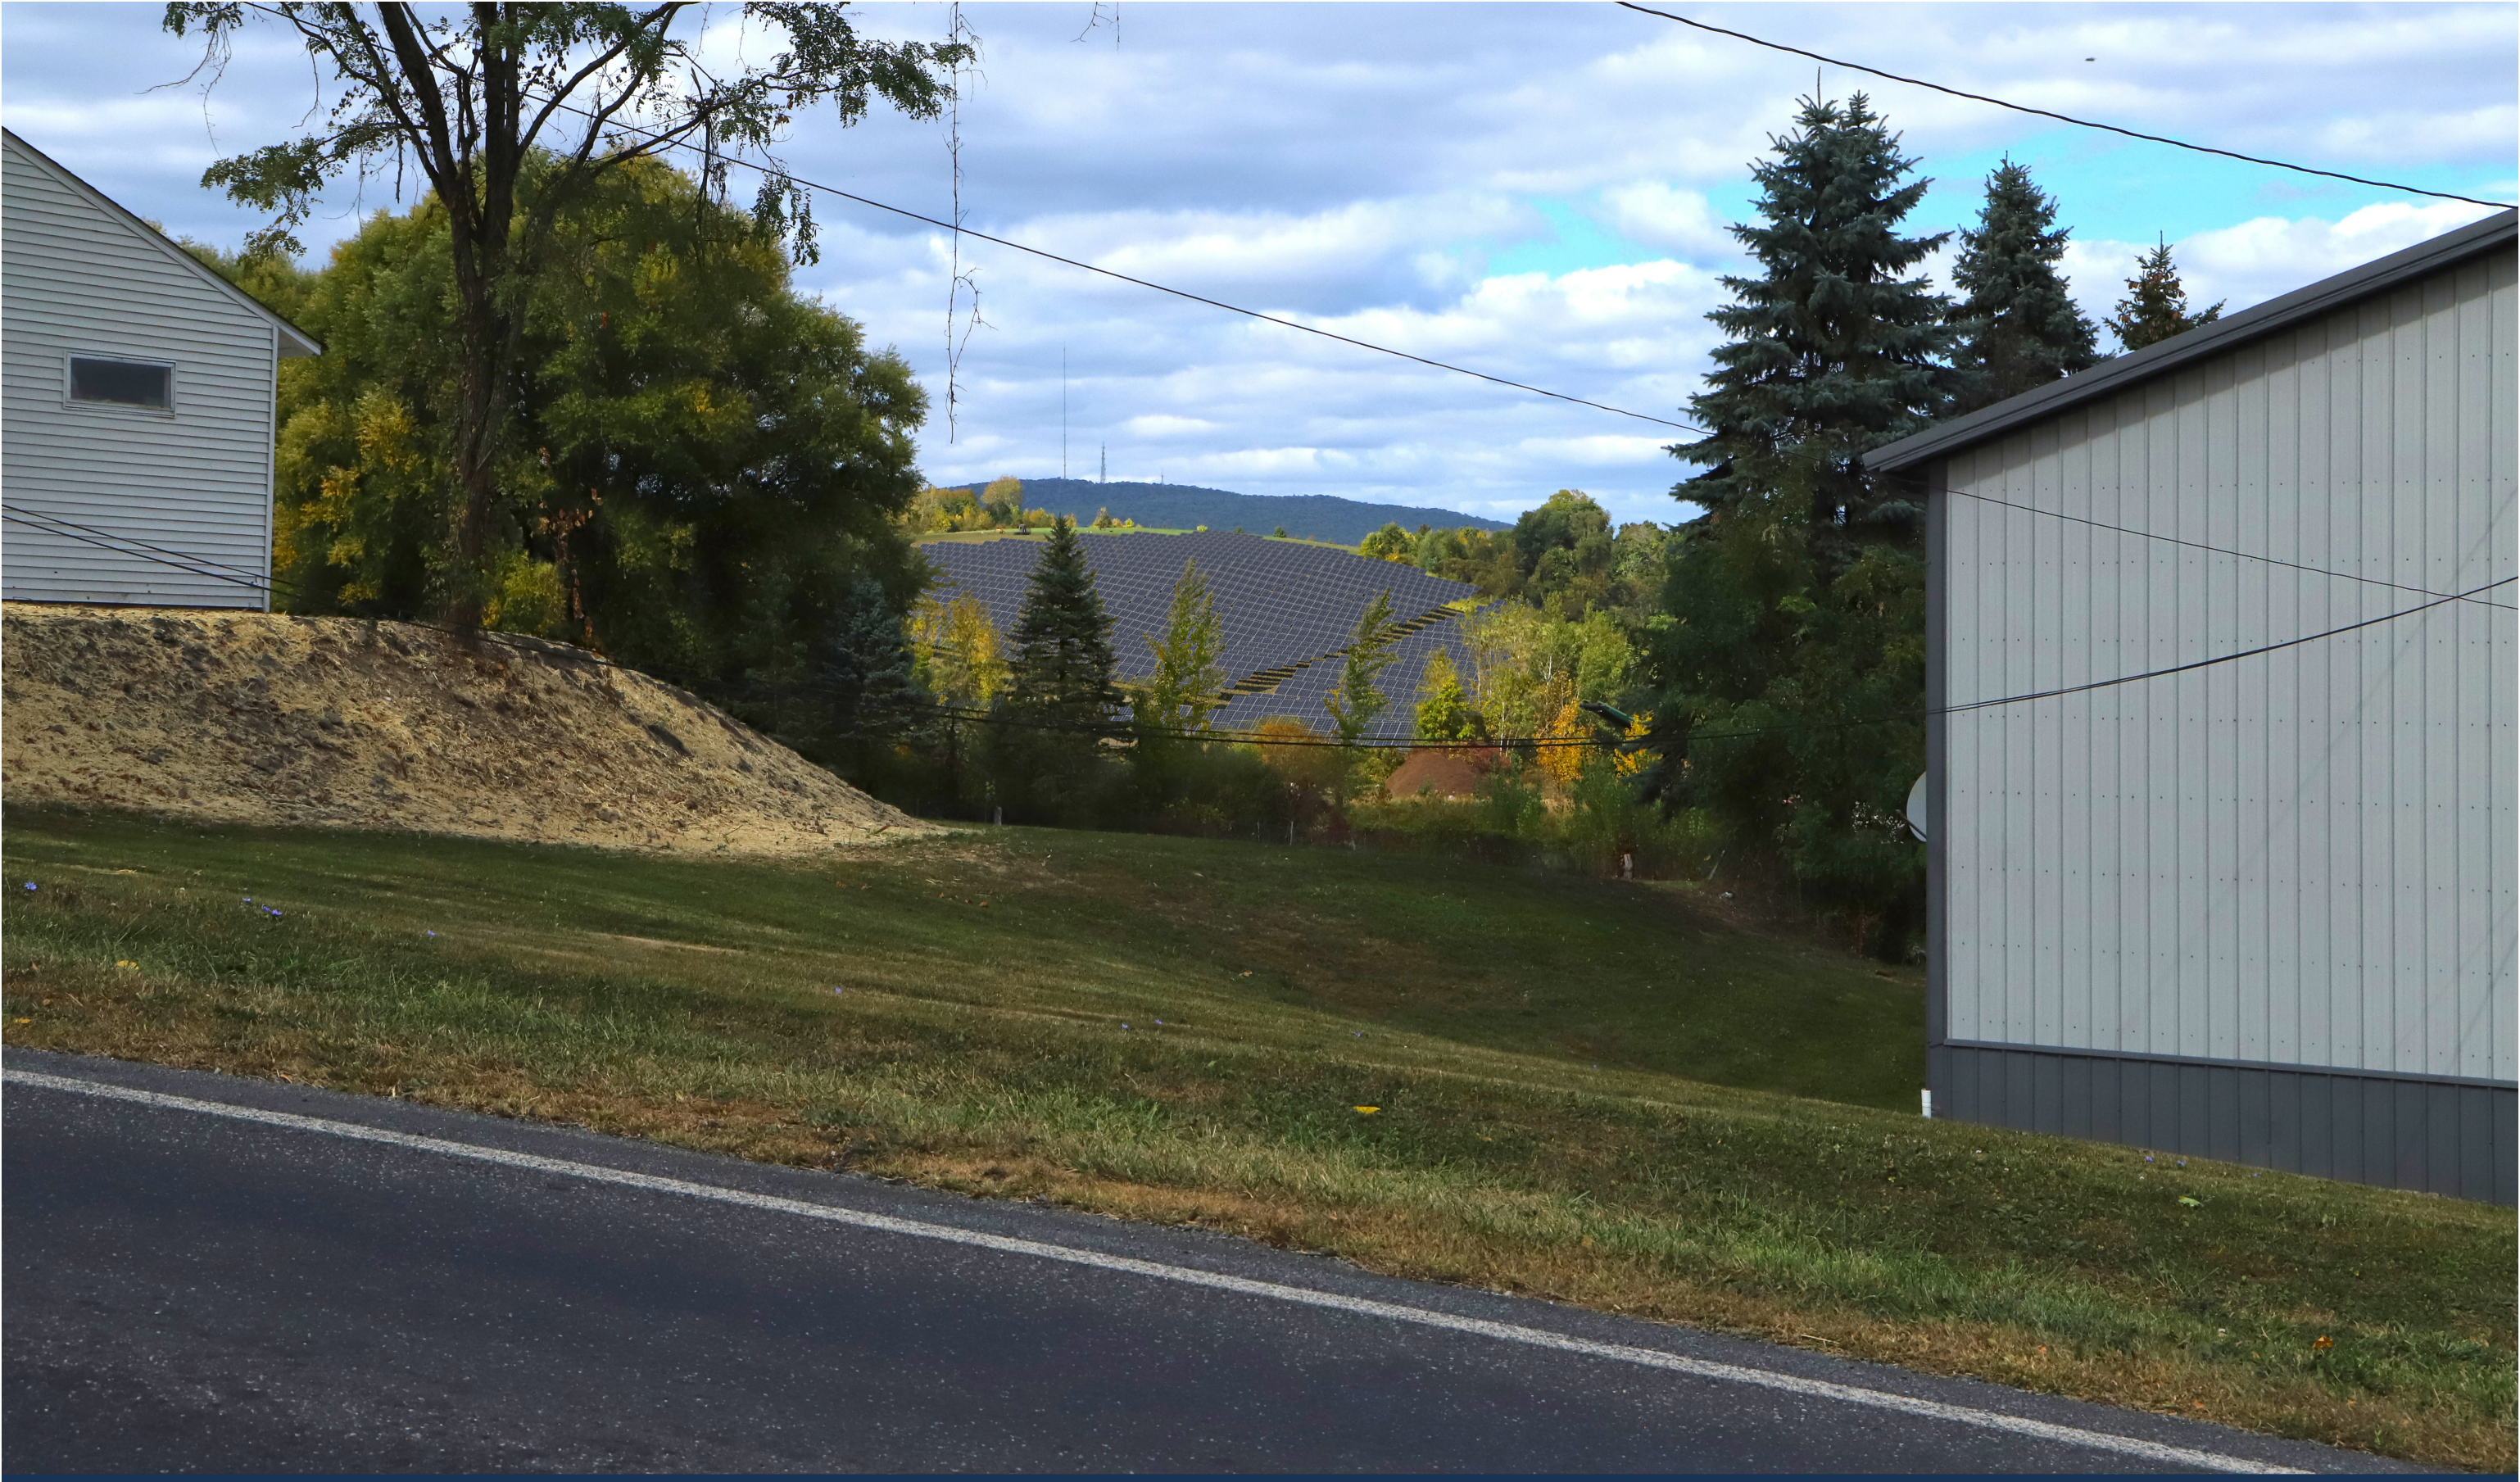
Date: September 24, 2024
Time: 2:00 PM
Focal Length: 50 mm
Photo Location: 41° 39' 54.7128" N, 73° 58' 22.0620" W

PV Panel: 2 panel
Orientation: Portrait
Racking: Fixed Tile
Max Height: 15 feet
Fence: 8 foot Wood Post with Agricultural Fencing

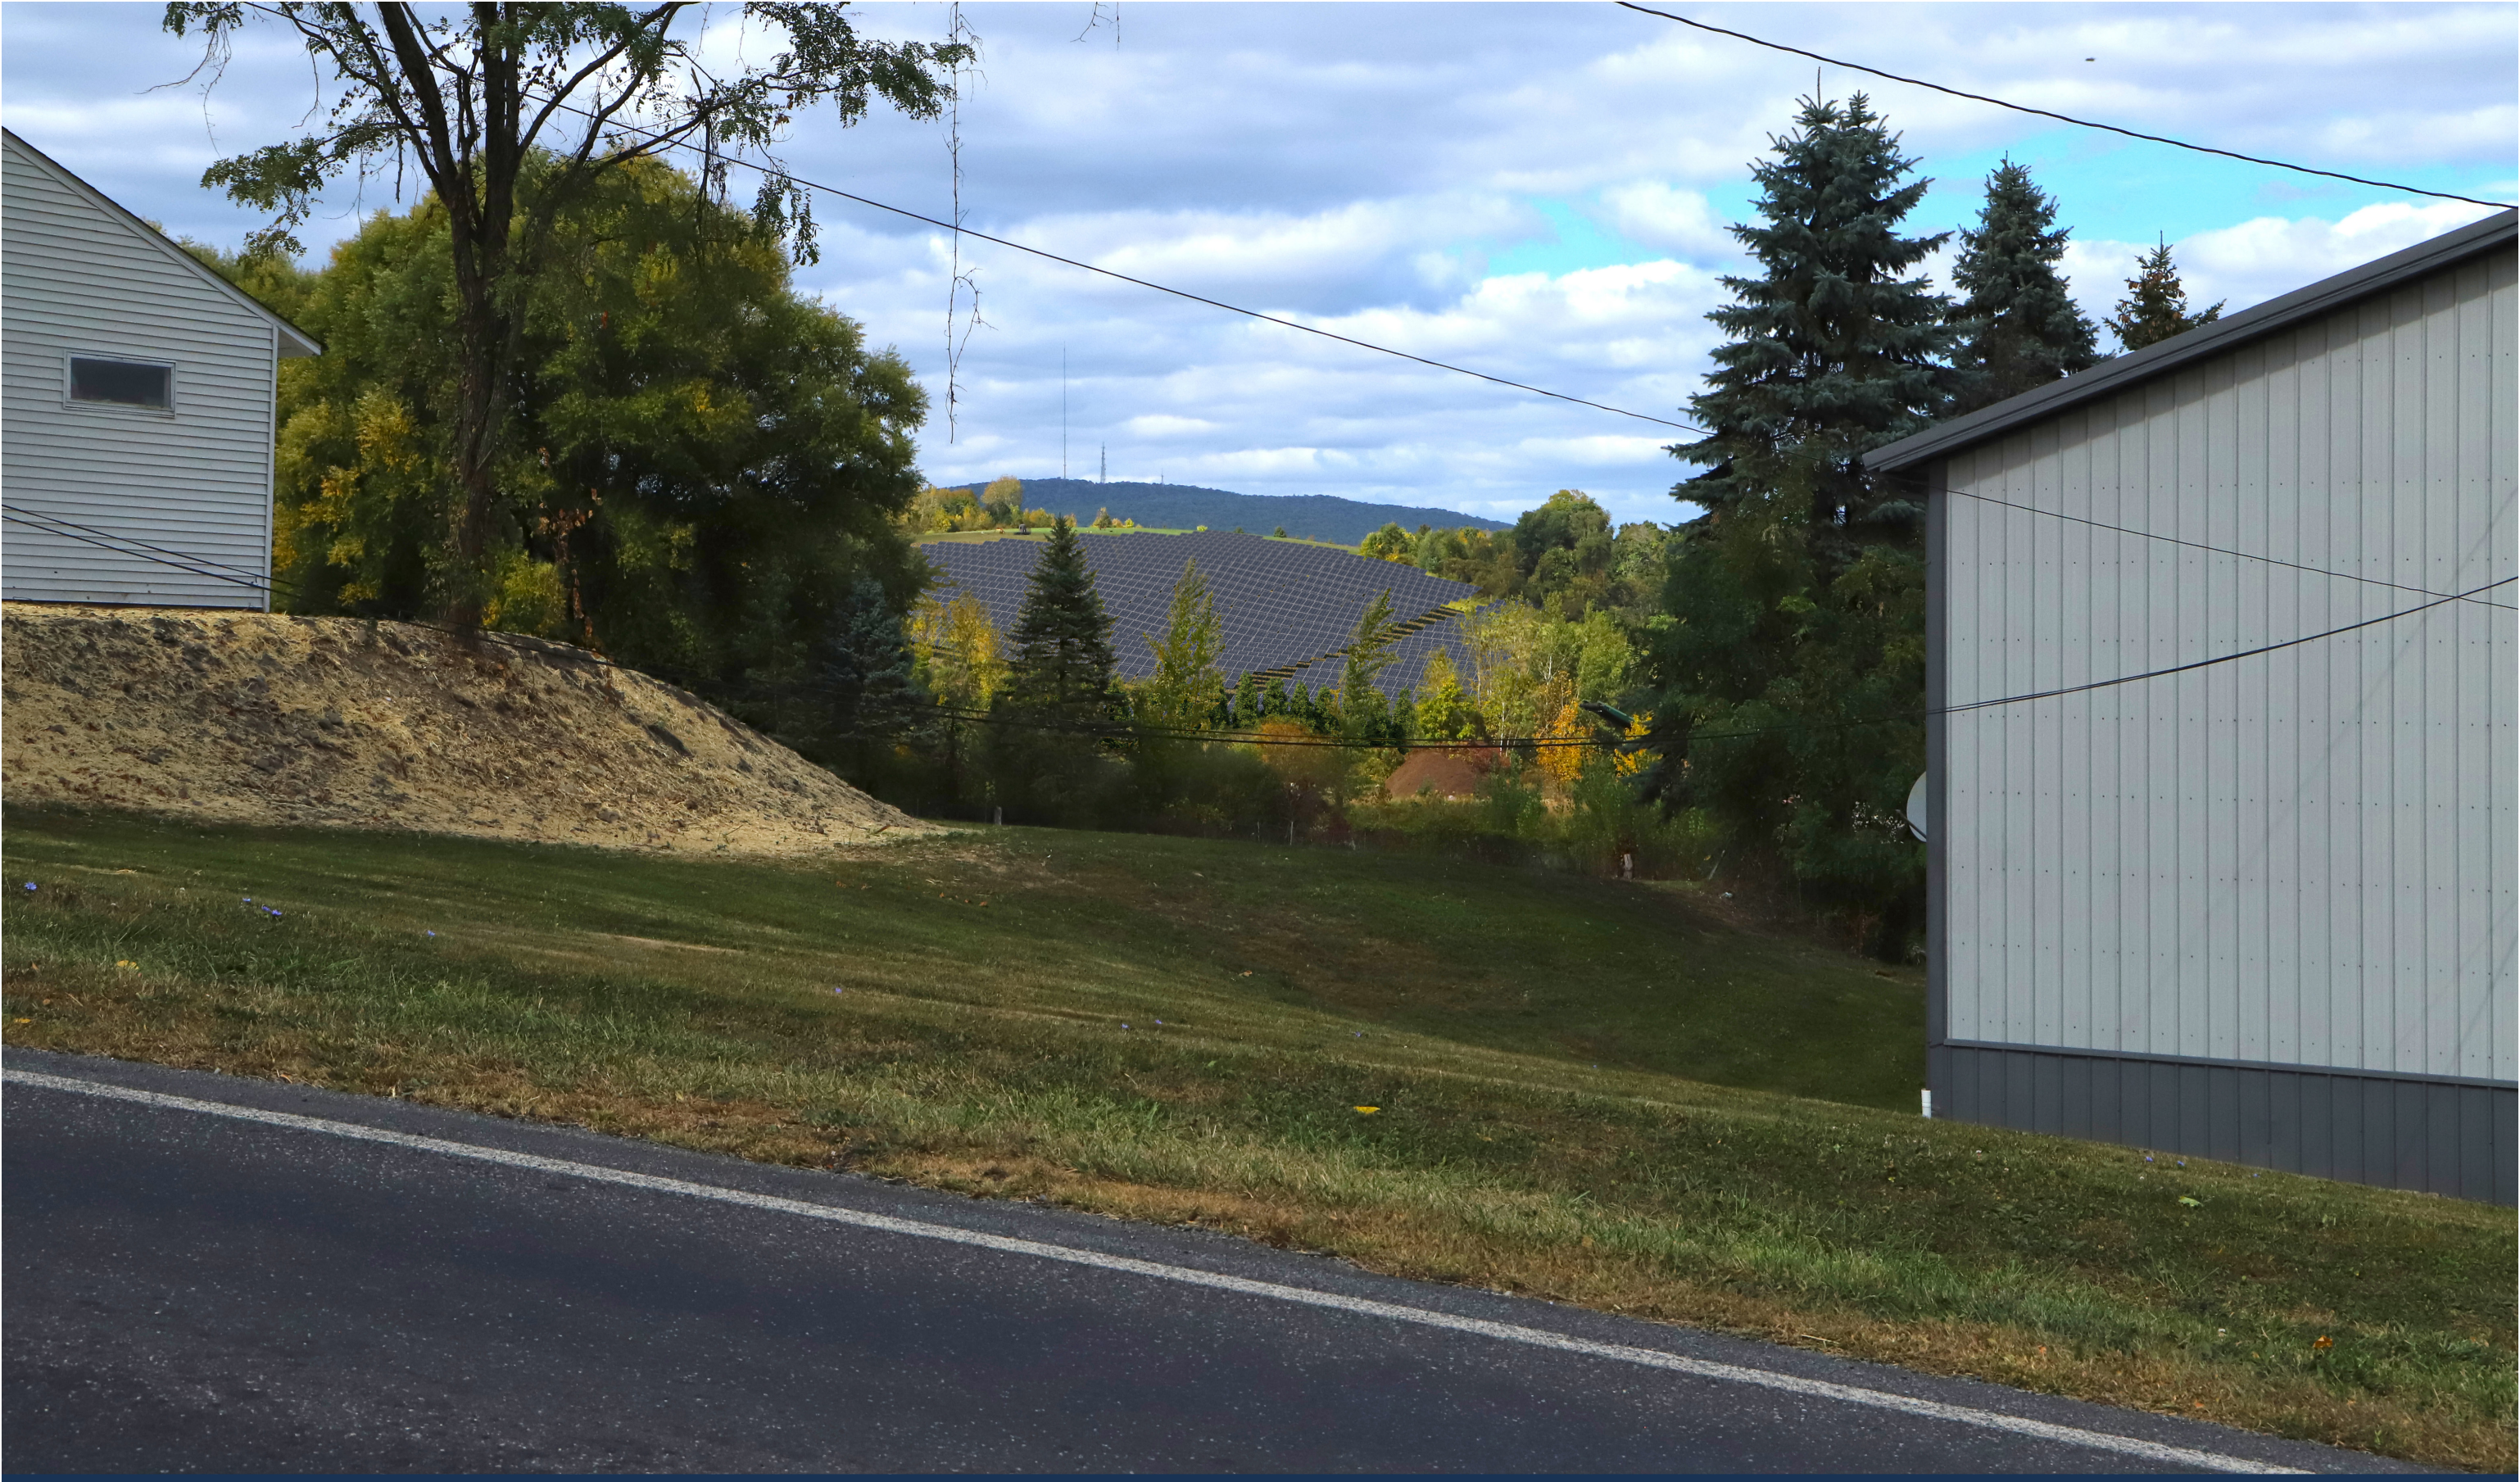
SIMULATED CONDITION - With Landscape Mitigation (At Year 5)
Photo 3: Milton Turnpike near #170
Distance to project: 710 Feet

Date: September 24, 2024
Time: 2:00 PM
Focal Length: 50 mm
Photo Location: 41° 39' 54.7128" N, 73° 58' 22.0620" W

PV Panel: 2 panel
Orientation: Portrait
Racking: Fixed Tile
Max Height: 15 feet
Fence: 8 foot Wood Post with Agricultural Fencing

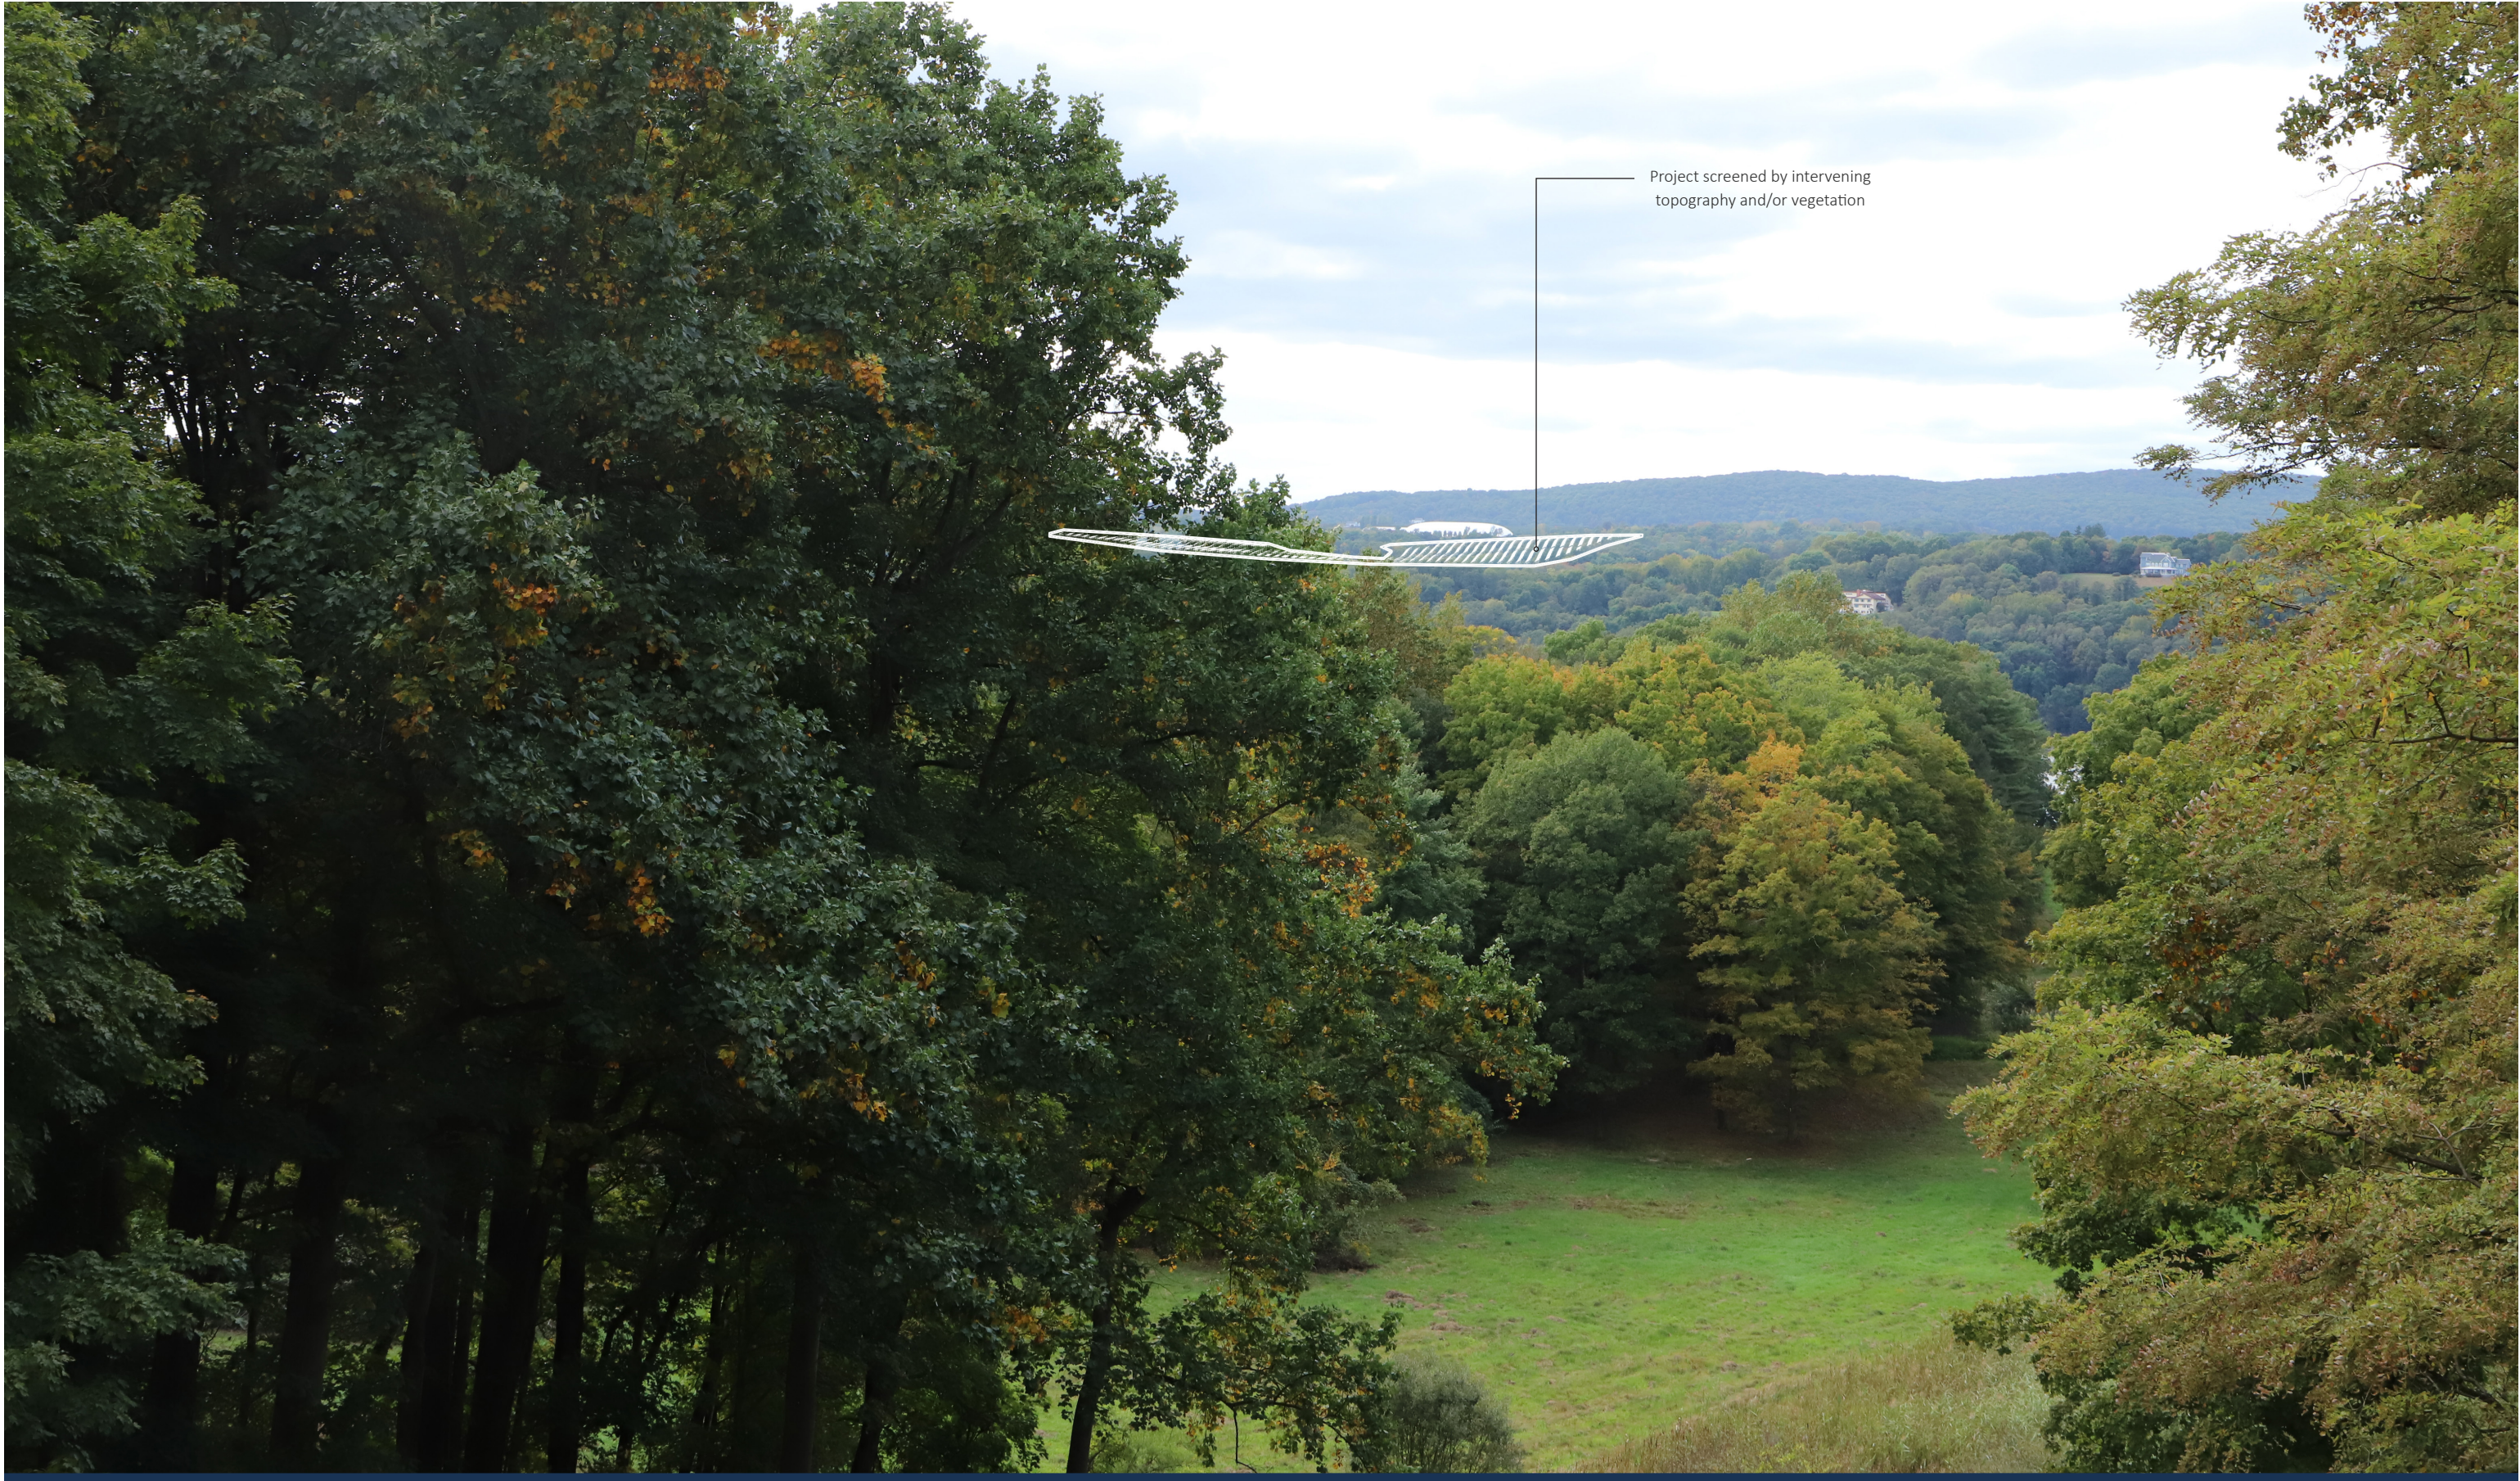
SIMULATED CONDITION
Photo 4: South Road at Locust Grove Estate
Distance to project: 2.1 miles

Date: September 24, 2024
Time: 3:30 PM
Focal Length: 50 mm
Photo Location: 41° 40' 24.0852" N, 73° 55' 55.4916" W

PV Panel: 2 panel
Orientation: Portrait
Racking: Fixed Tile
Max Height: 15 feet
Fence: 8 foot Wood Post with Agricultural Fencing
