APPENDIX B: Existing Conditions

Route 9W Corridor Management Plan

**Towns of Marlborough and Lloyd
Ulster County, NY**

EXISTING CONDITIONS REPORT

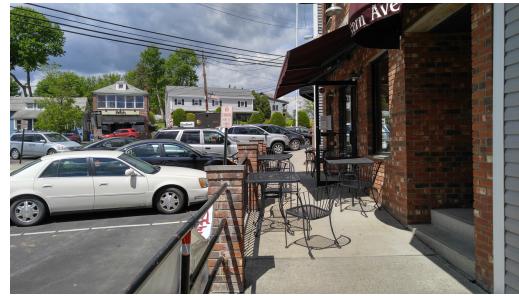
On the west side of 9W, there is no crosswalk across the Western Avenue intersection from south to north due to the sidewalk elevation sitting well above that of Route 9W on the north side of the road (Fig. 9). The sidewalk on the north side can be accessed via the on-street parking stalls on Western Avenue and is used as an outdoor seating area for adjacent businesses (Fig. 10 & 11). The sidewalk ramps down as it turns the corner around Western Avenue at Farmer's Insurance onto Route 9W (Fig. 12). A seven (7') foot shoulder borders the west side of Route 9W along the ramp.

Figure 11: Outdoor seating for restaurant on sidewalk north side of Western Ave, looking west

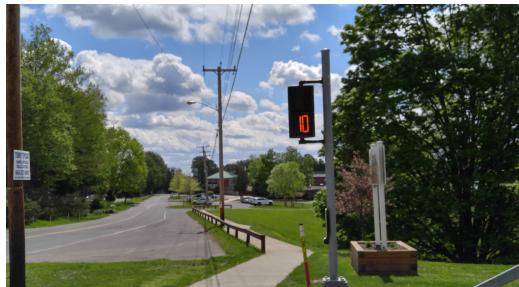
protected by a shoulder of five-and-a-half (5.5') feet. The ADA-compliant sidewalk improvements continue along the west side of Route 9W up to Young Avenue, where it meets a signalized crosswalk across Route 9W with pedestrian actuation and countdown signals serving the elementary school (Fig. 22 & 23). There is no sidewalk along the east side of Route 9W along the elementary school property, but there is an eight (8') foot shoulder, often used as a right-turn lane onto Young Avenue. There is a pedestrian crossing caution sign on the east/northbound side of the road approaching the school, but no explicit "School Zone" signage (Fig.24).

Figure 22: Countdown at crosswalk across 9W to Elementary School, looking east

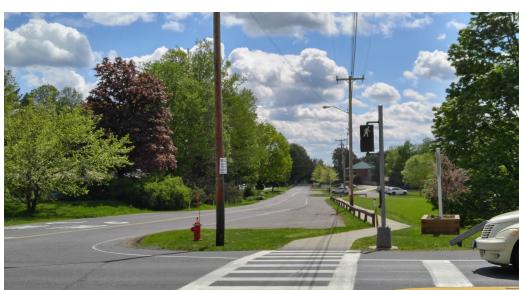
Figure 23: Signalized crosswalk across 9W to Elementary School, looking east

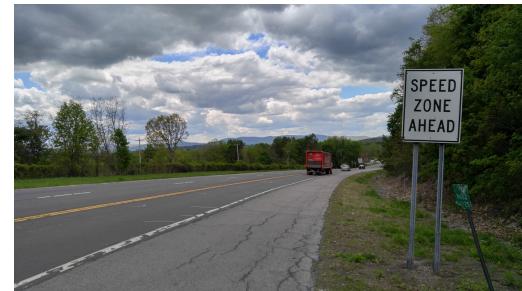
Figure 29: Reduced speed area going downhill from Lauria Drive toward Riverview Drive as 9W southbound becomes 1 lane, looking south

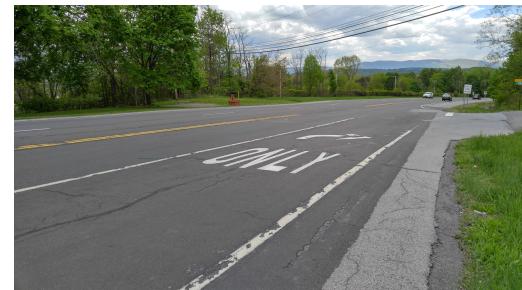
Figure 30: Right-turn lane onto Lauria Drive from 9W southbound, looking south

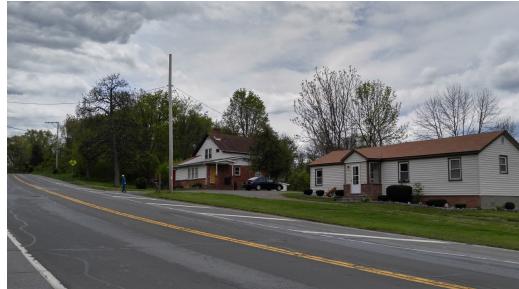
Figure 32: Cross-hatching to reduce roadway width on 9W southbound, looking southwest

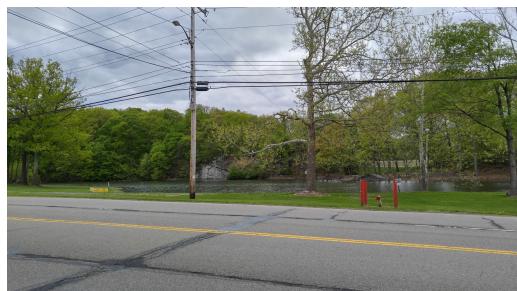
Figure 37: Cluett Schantz Memorial Park on 9W southbound, looking west toward park

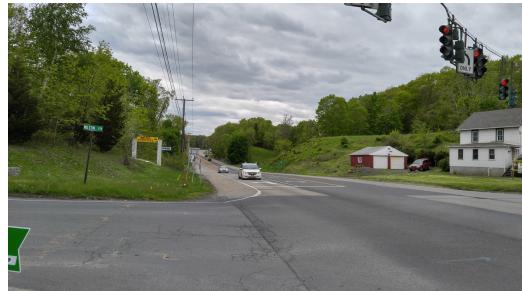
The east shoulder is seven (7') feet wide south of Saint James Road and 6.5 feet to the north of Saint James Road (Fig. 38). The shoulder on the western side of 9W in this location is 12.5 feet to the south and seven (7') feet to the north. The west side decreases gradually to five (5') feet in width at Milton Turnpike and the east side increases to around 8.5 feet wide. There is a left-turn lane from the southbound side onto South Road near the Town of Marlborough Town Hall, as well as left-turn lanes from both directions onto Milton Turnpike at the signalized four-road intersection. There are no crosswalks, push buttons or ADA improvements at the Milton Turnpike intersection (Fig. 39).

Figure 39: One northbound and southbound lane and left-turn lane onto Milton Turnpike on 9W northbound

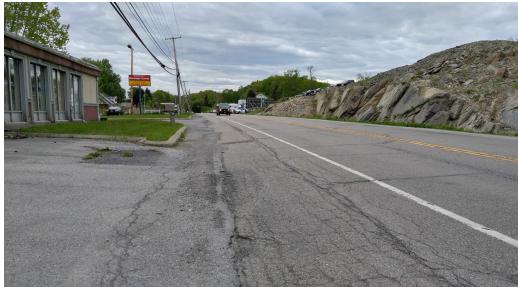
The shoulders remain in fair to good condition north of Milton Turnpike. At New Road, the shoulders are generally eight (8') feet on both sides of the corridor (Fig. 42). The shoulder width increases south of Mahoney Road to eight-and-a-half (8.5') feet on the west side and eleven (11') feet on the east. The east (northbound) shoulder is consistently ten feet (10') wide north of Mahoney Road (Fig. 41).

Figure 42: Open curb cut on 9W northbound at New Road, looking south

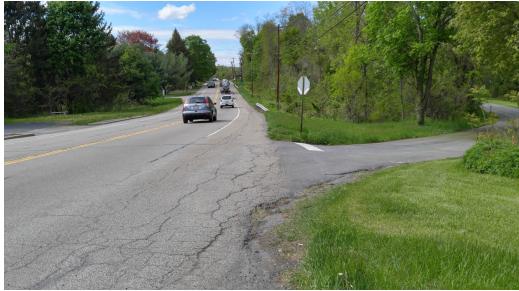
Figure 45: 9W northbound at south Sam Williams Road, looking north
