SARATOGA
ASSOCIATES

HIGHLAND SOLAR PROJECT
Town of Marlborough, Ulster County, NY

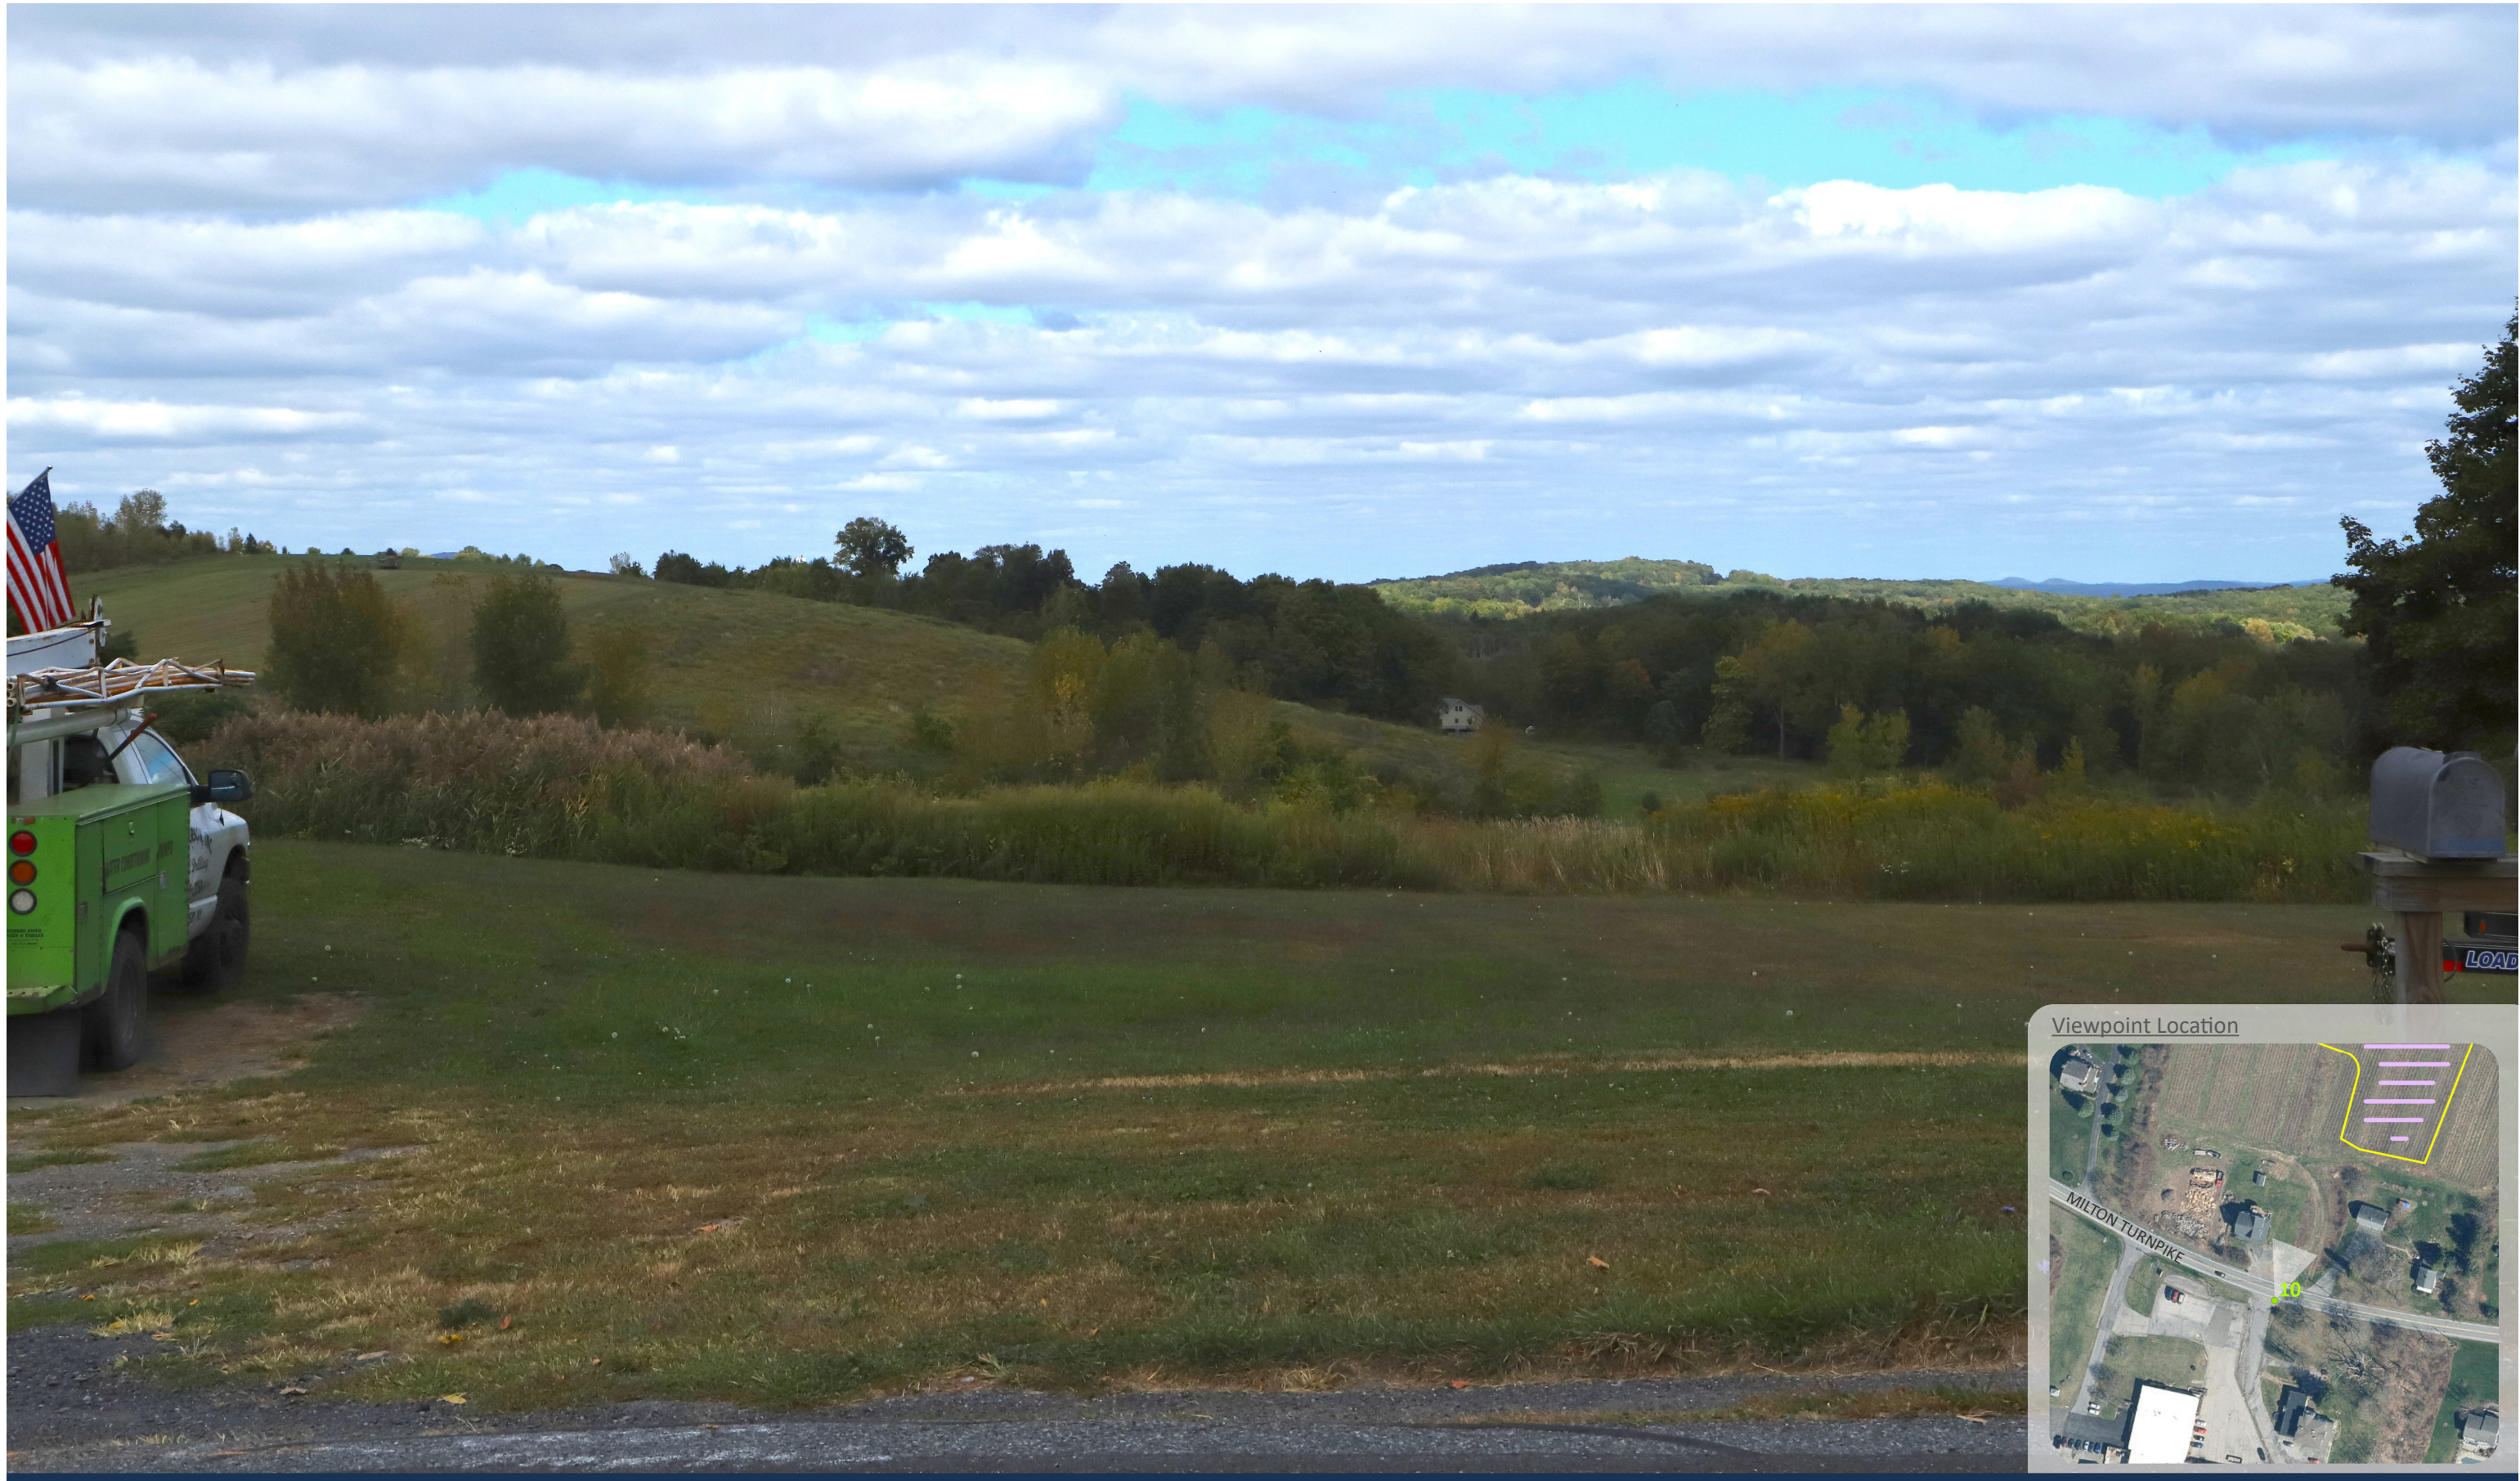
Viewpoint 1 | Milton Turnpike near #194

EXISTING CONDITION

Date: September 24, 2024
Time: 1:50 PM
Focal Length: 50 mm
Photo Location: 41° 39' 56.0232" N, 73° 58' 33.4524" W

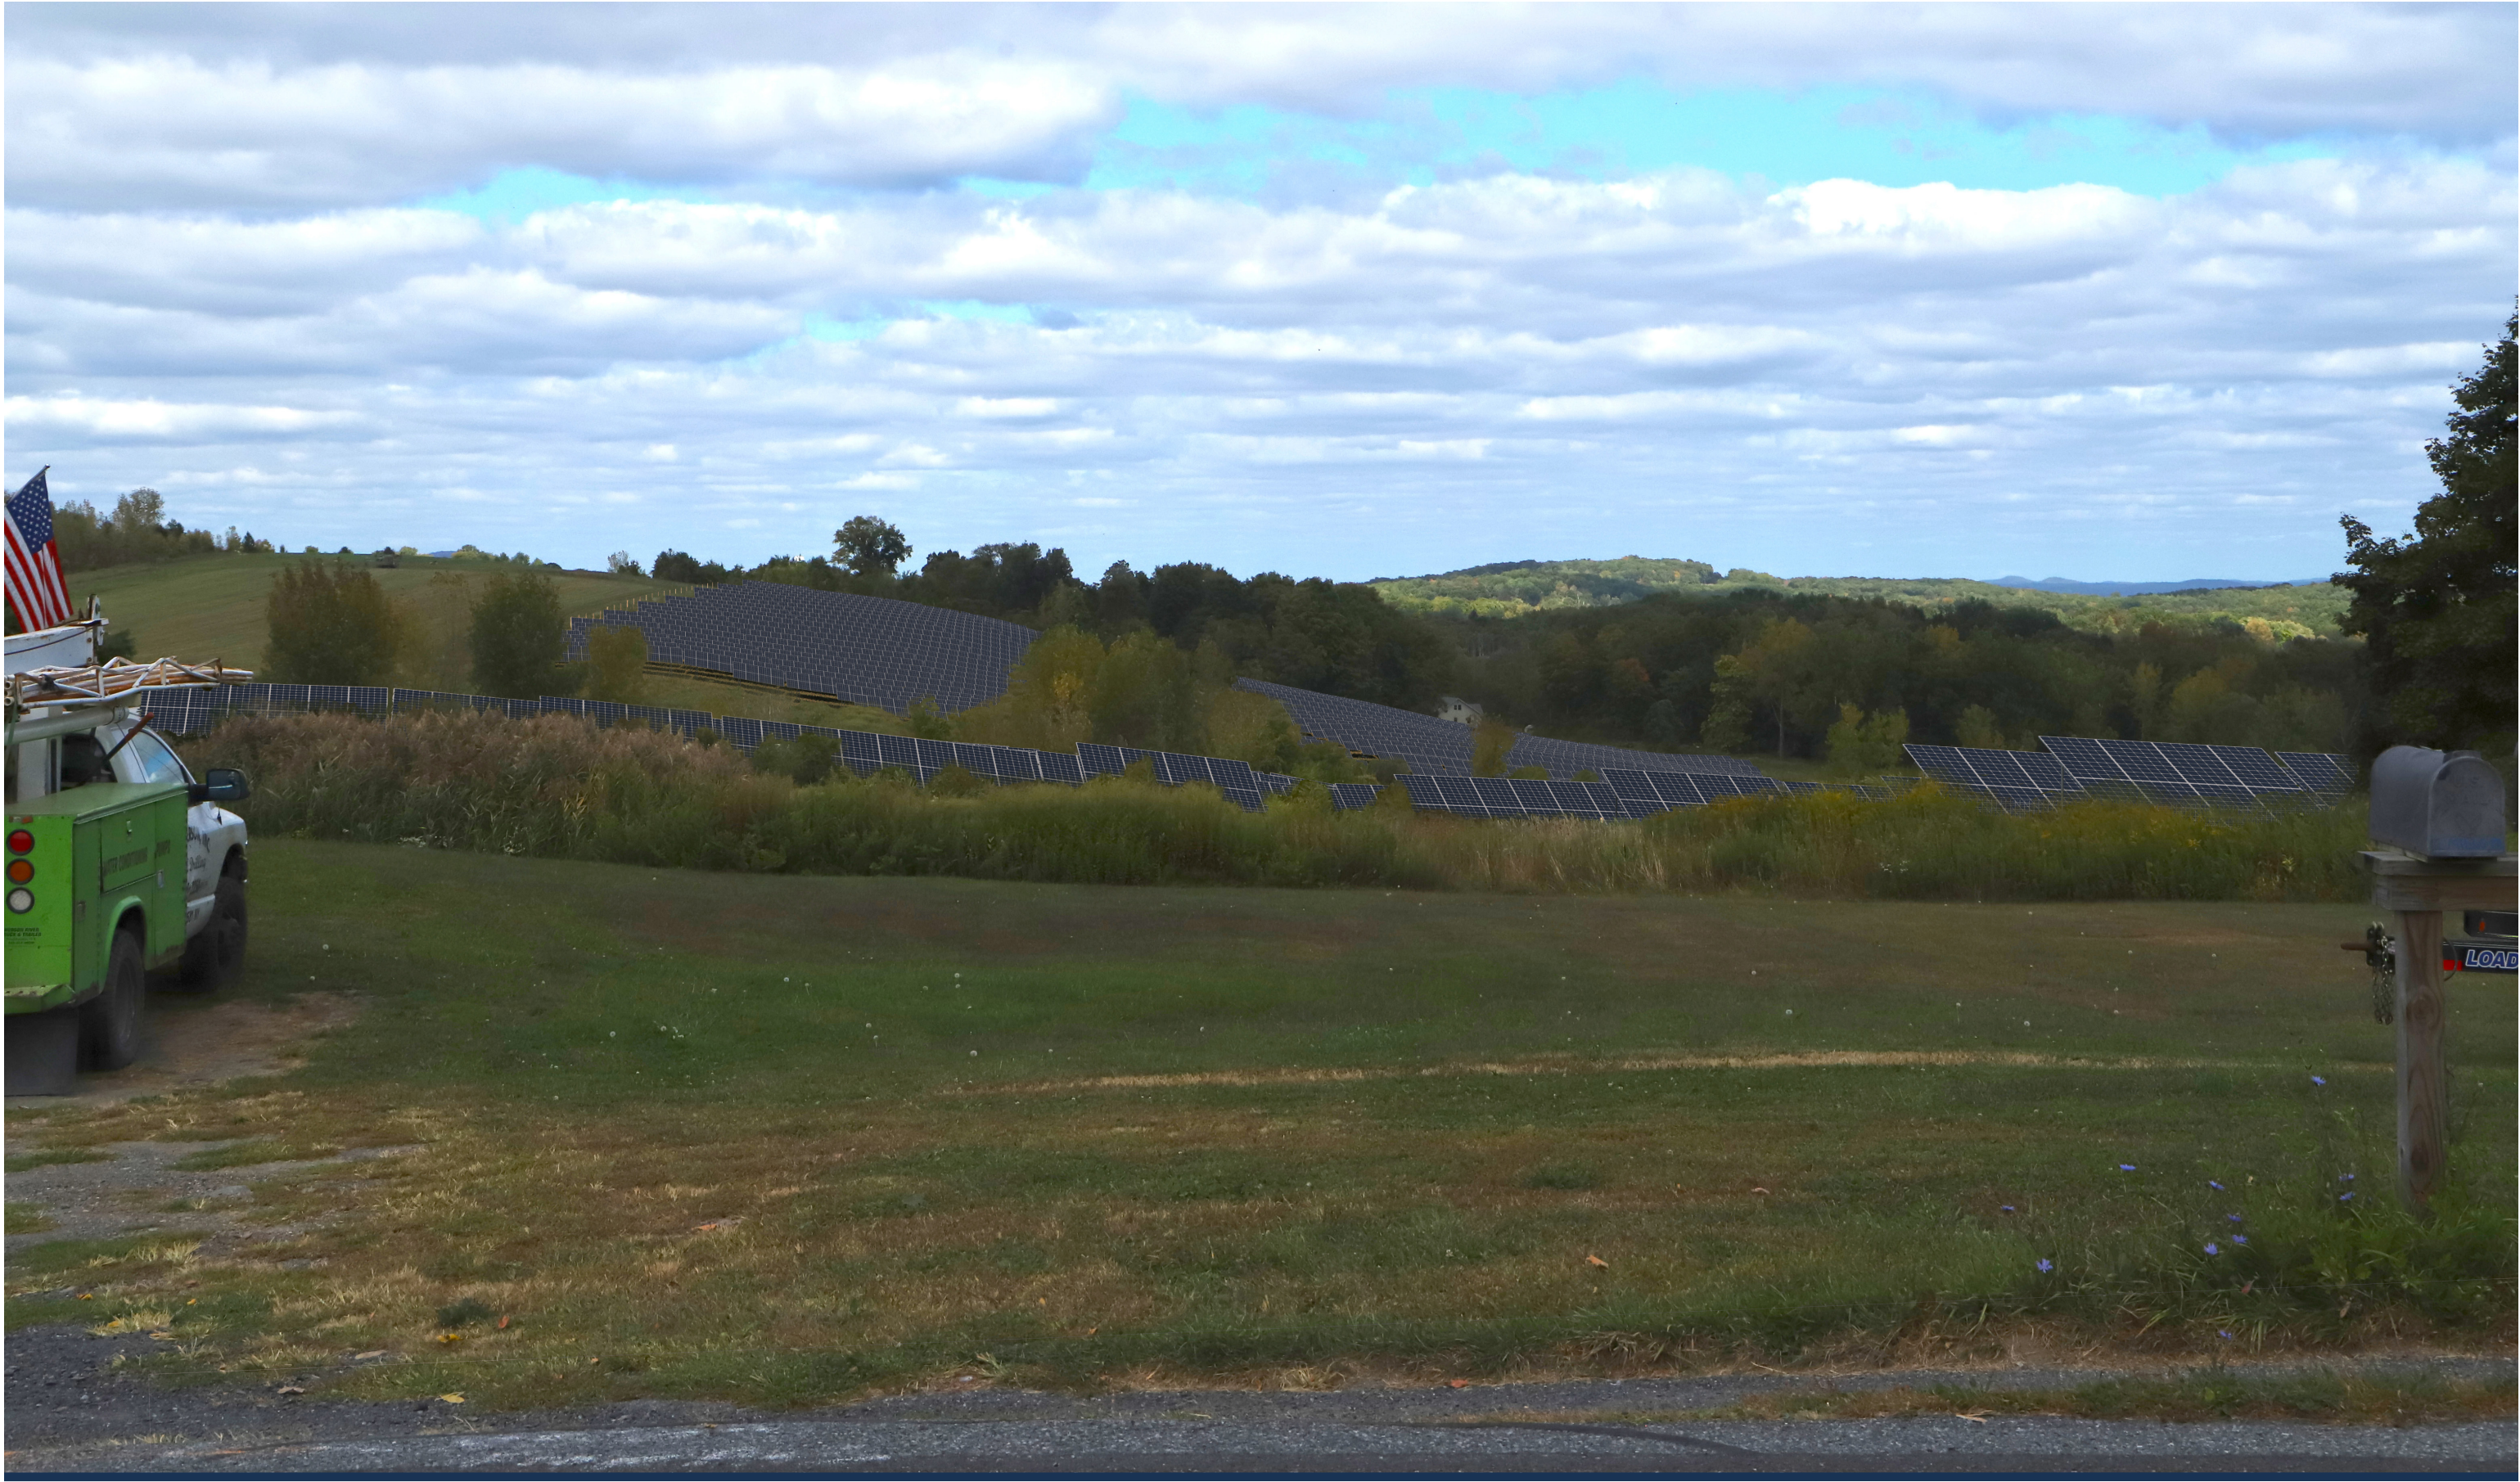
Viewpoint 1 | Milton Turnpike near #194
Distance to project: 260 Feet

SIMULATED CONDITION

Date: September 24, 2024
Time: 1:50 PM
Focal Length: 50 mm
Photo Location: 41° 39' 56.0232" N, 73° 58' 33.4524" W

PV Panel: 2 panel
Orientation: Portrait
Racking: Fixed Tile
Max Height: 15 feet
Fence: 8 foot Wood Post with Agricultural Fencing

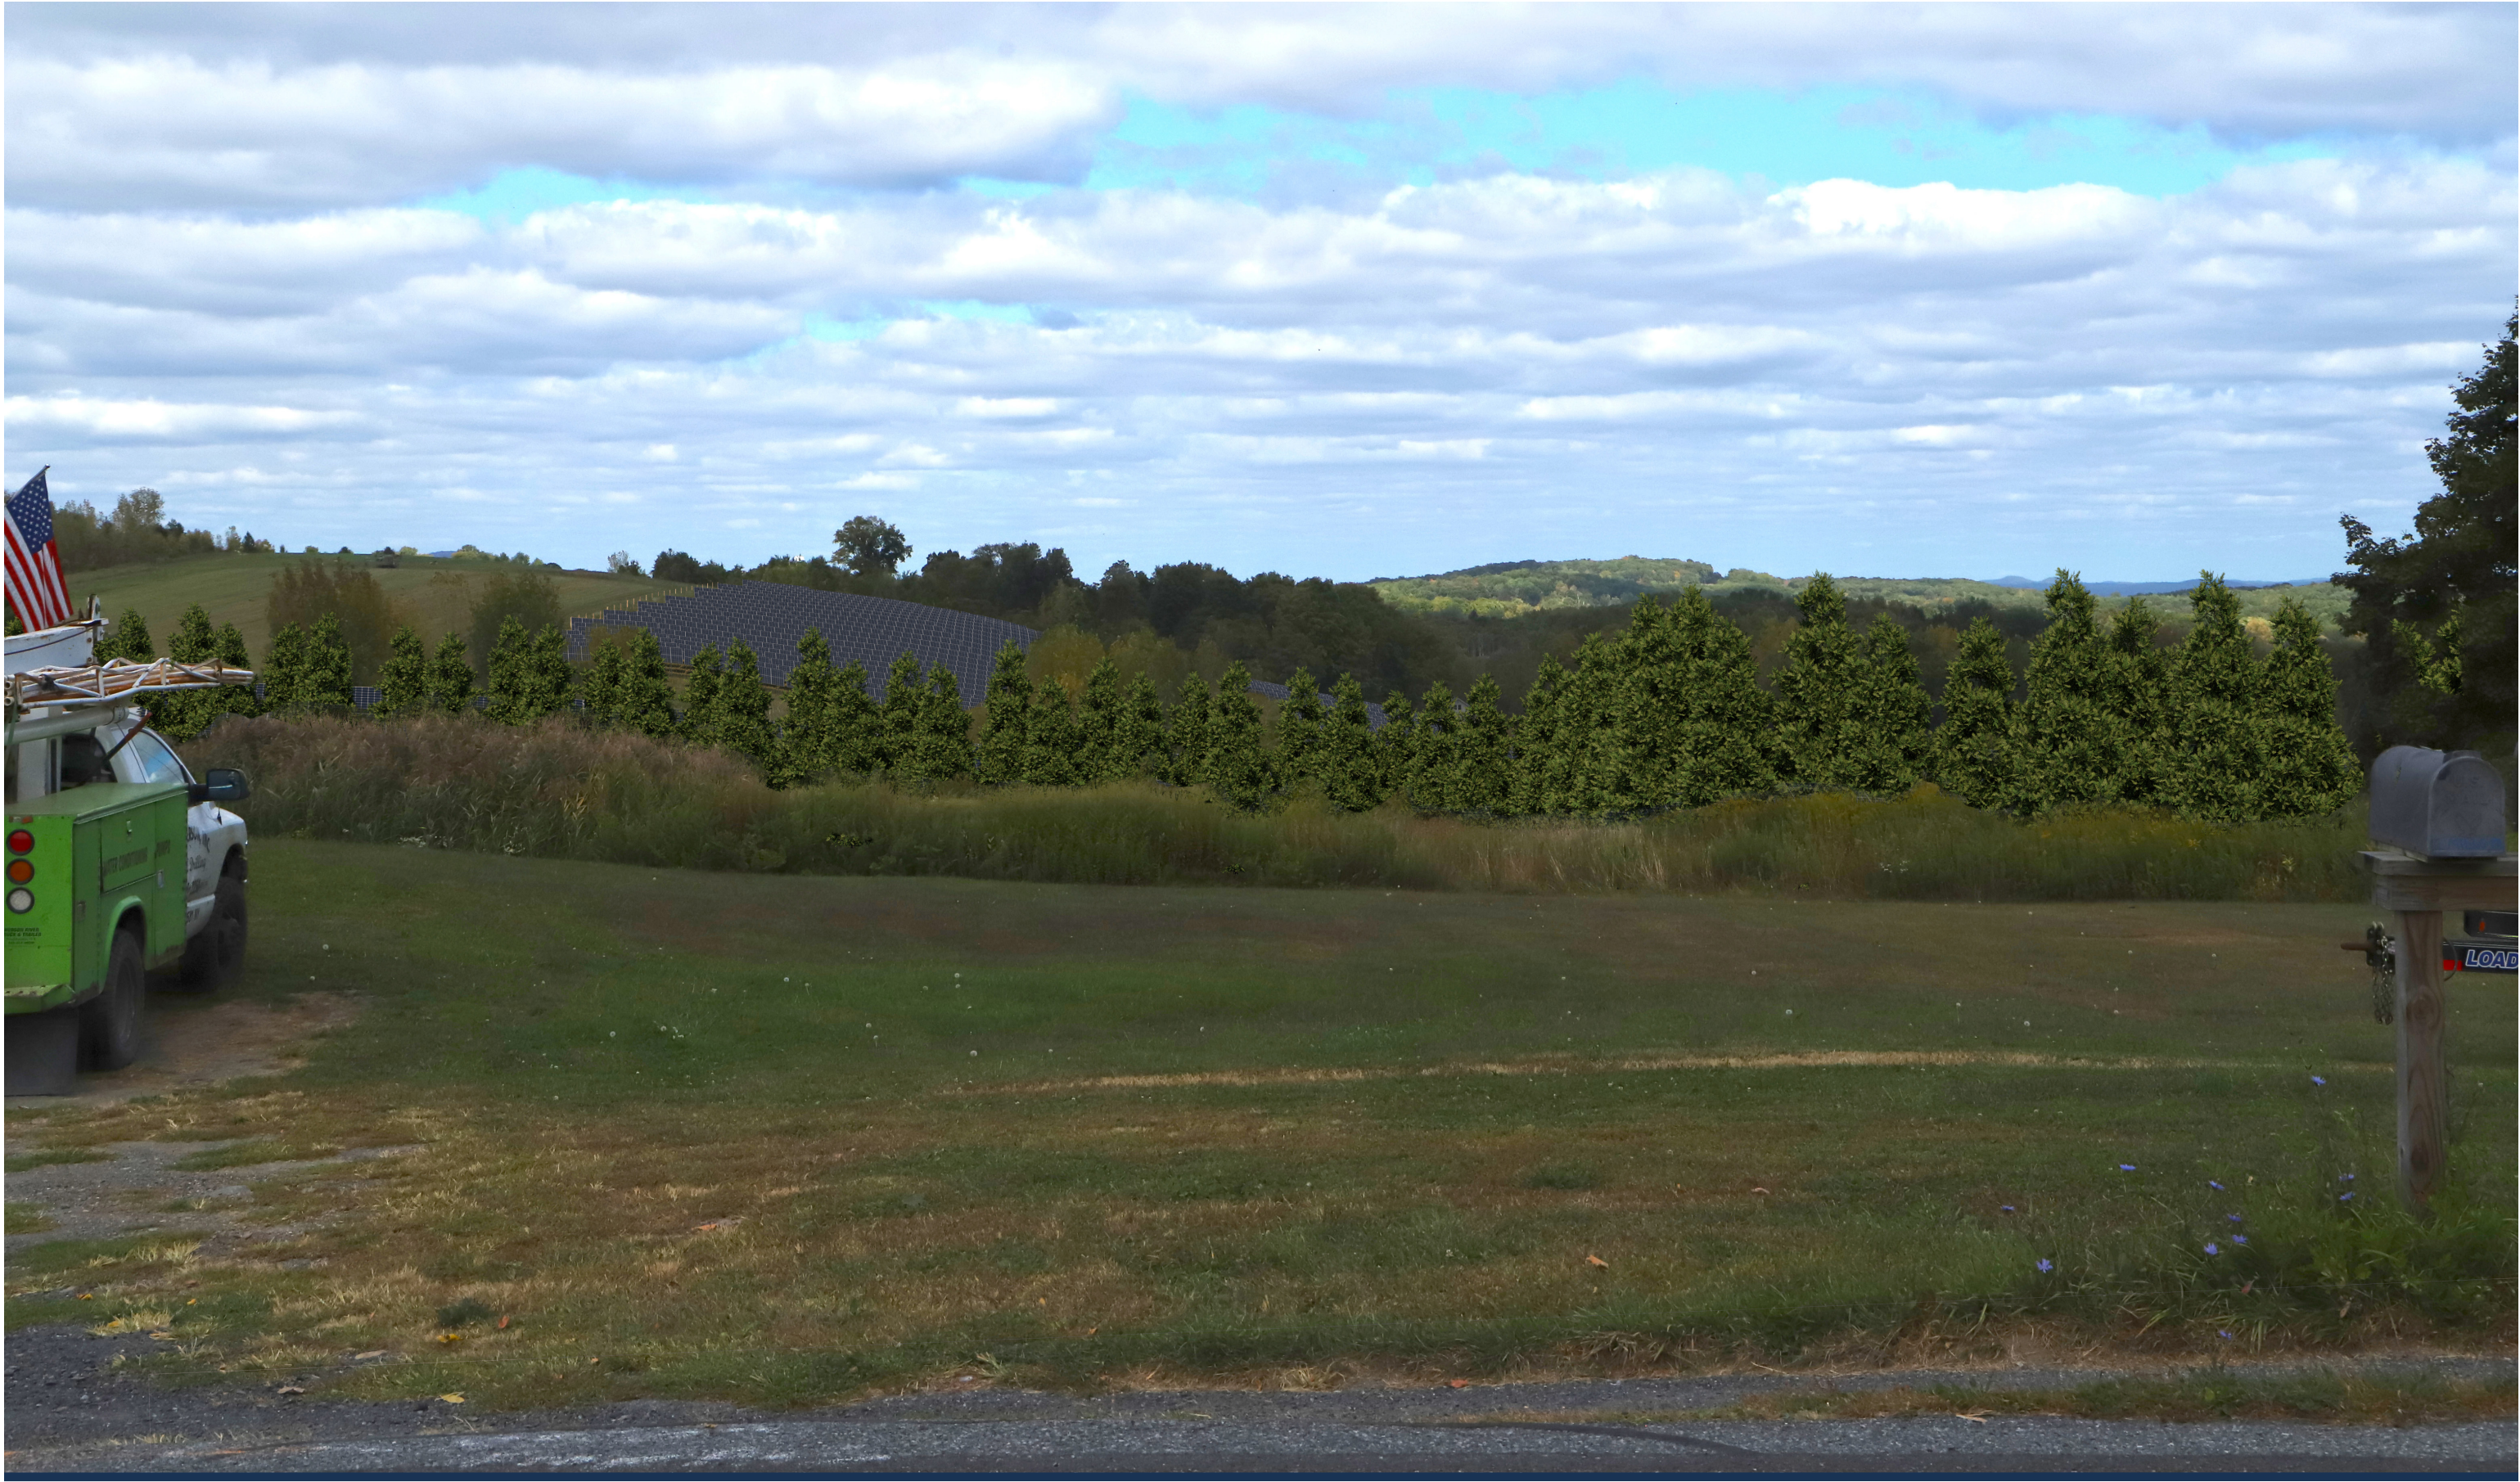
Photo 1: Milton Turnpike near #194

SIMULATED CONDITION - With Landscape Mitigation (At Year 5)

Distance to project: 260 Feet

Date: September 24, 2024
Time: 1:50 PM
Focal Length: 50 mm
Photo Location: 41° 39' 56.0232" N, 73° 58' 33.4524" W

PV Panel: 2 panel
Orientation: Portrait
Racking: Fixed Tile
Max Height: 15 feet
Fence: 8 foot Wood Post with Agricultural Fencing

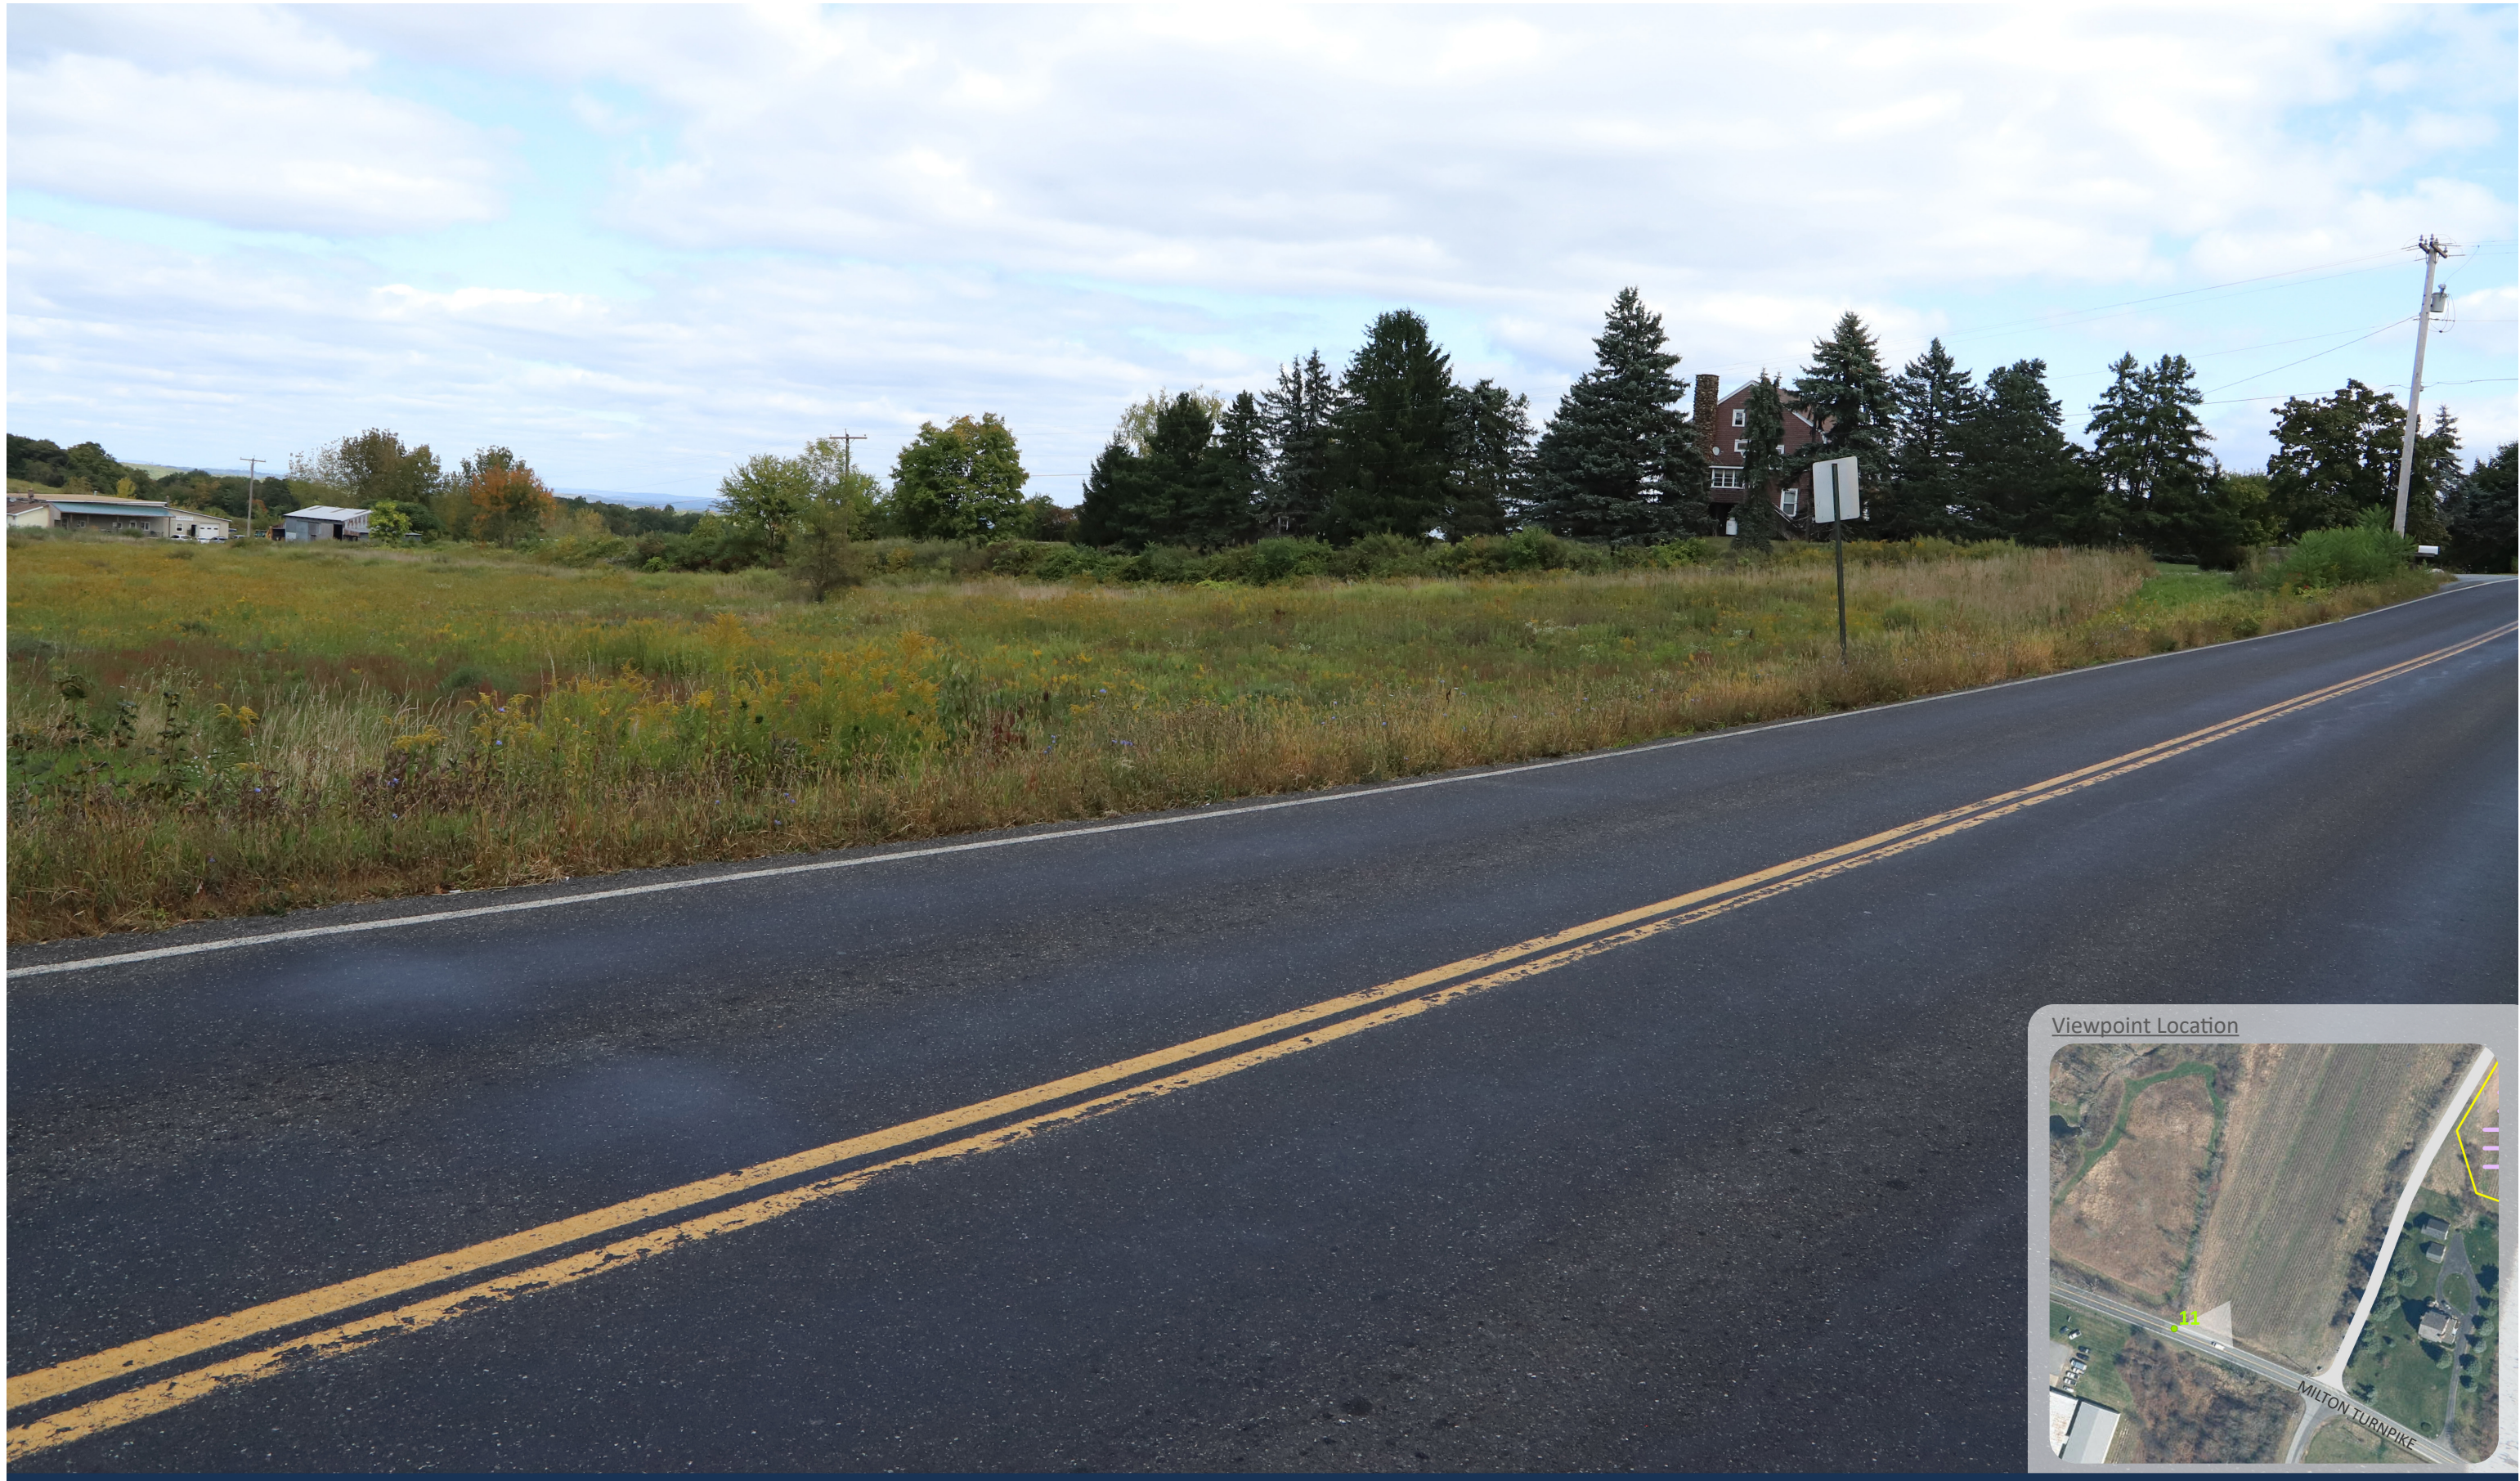
EXISTING CONDITION
Photo 2: Milton Turnpike near #235

Photograph Information
Date: September 24, 2024
Time: 1:55 PM
Focal Length: 24 mm
Photo Location: 41° 39' 59.4720" N, 73° 58' 43.1040" W

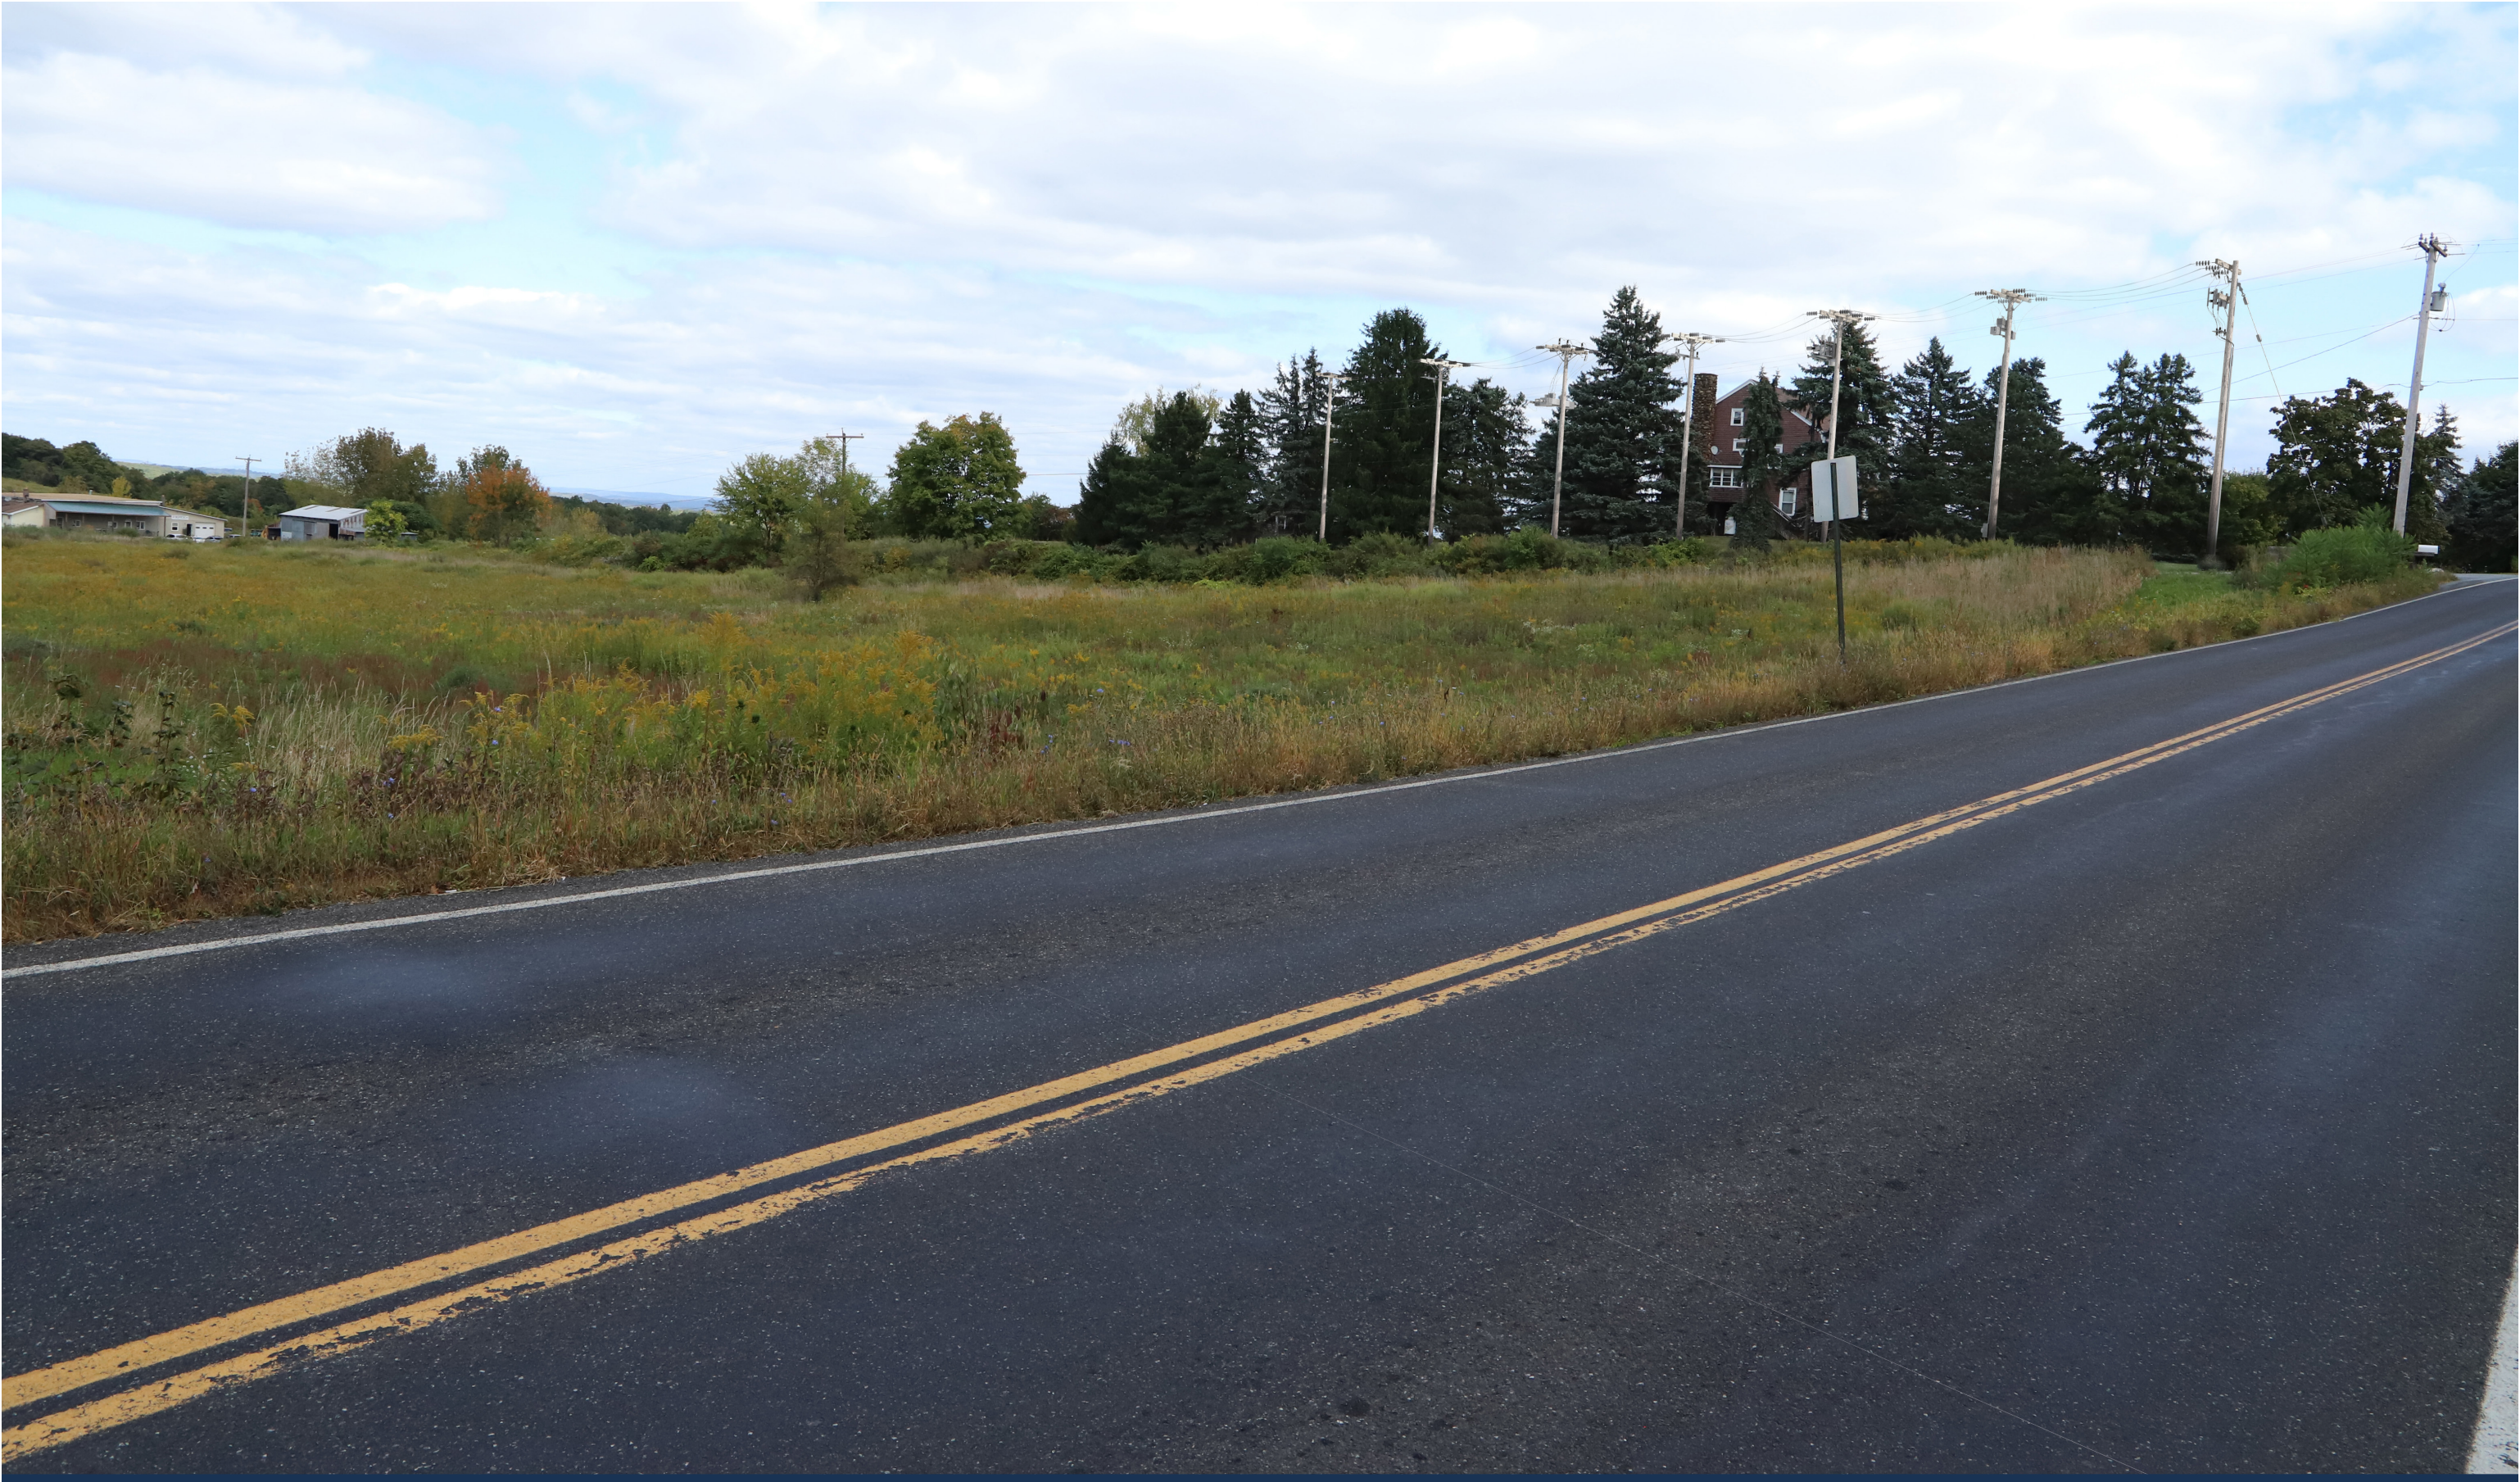
SIMULATED CONDITION
Photo 2: Milton Turnpike near #235
Distance to project: 530 Feet

Date: September 24, 2024
Time: 1:55 PM
Focal Length: 24 mm
Photo Location: 41° 39' 59.4720" N, 73° 58' 43.1040" W

PV Panel: 2 panel
Orientation: Portrait
Racking: Fixed Tile
Max Height: 15 feet
Fence: 8 foot Wood Post with Agricultural Fencing
